# **IRRIGATION IMPROVEMENT PROJECT**

## **WORKING PAPER 26**

# **Options for Improving Zabid Main Canals**

December 2003

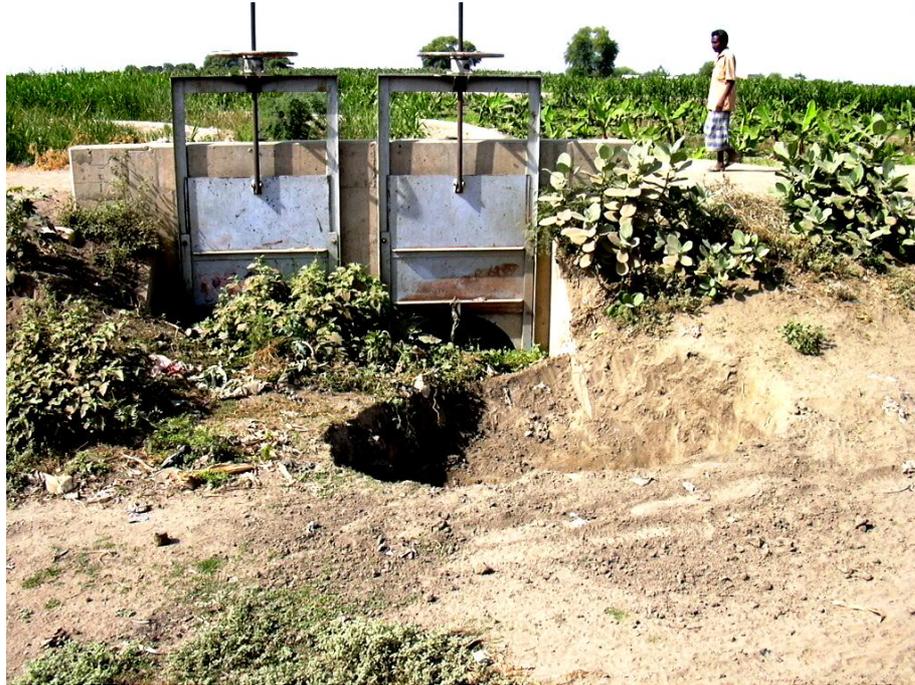
Most of the turnouts are pipe outlets provided with vertical sliding gates to facilitate flow regulation. In the start of every reach in general and in the first reach in particular, heavy deposits of sediment has completely blocked the turnouts, leaving it impossible for the farmers to have any diversion through these structures. Photograph 1 in Appendix A illustrates the choking problem.

*Choked Turnout*

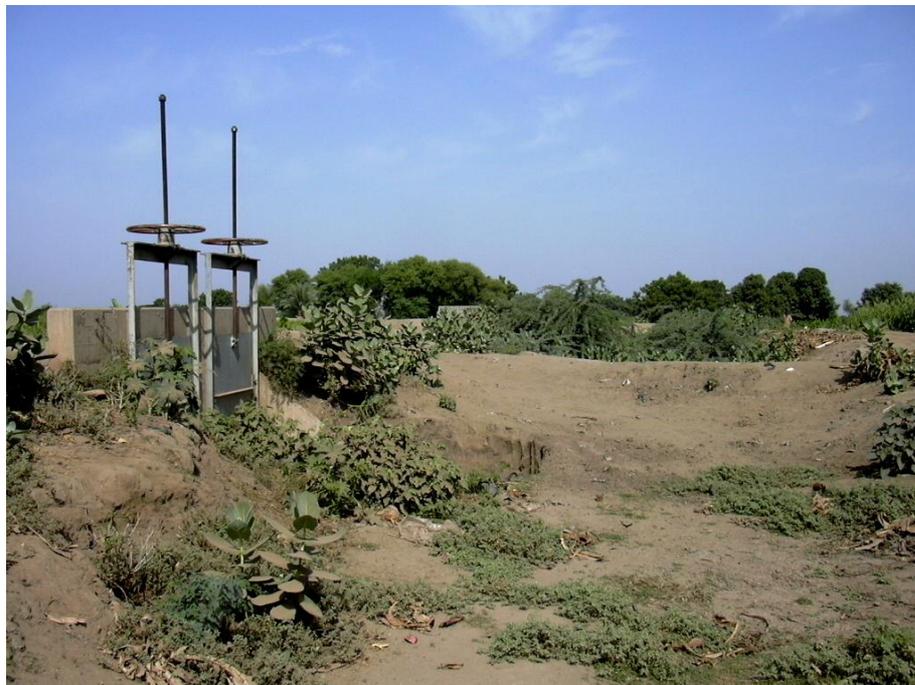
*Temporary Dike to Raise Water Level*

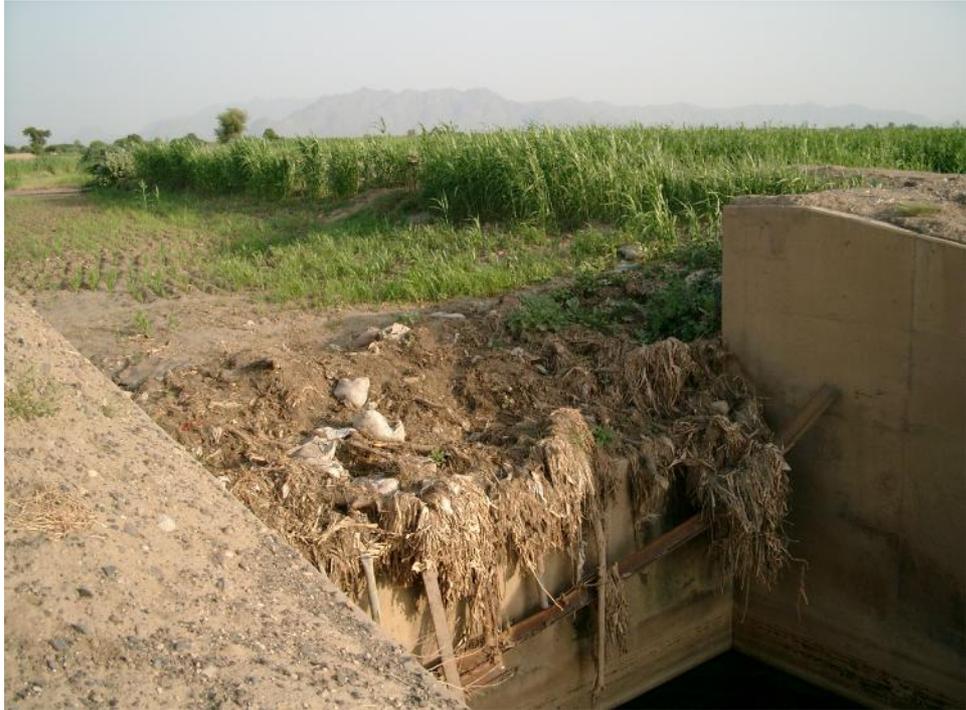
Farmers have found it necessary to raise the water level at the drop structures to generate command required for irrigating their fields. They do so by putting sand bags, weeds, banana stems and also the stones they remove from the protections downstream. When the dam is removed or washed out, the stones hit the chute and the baffle blocks provided in the energy dissipation structures and have destroyed some of those.

*Blocking at Drops To Raise Water Level*

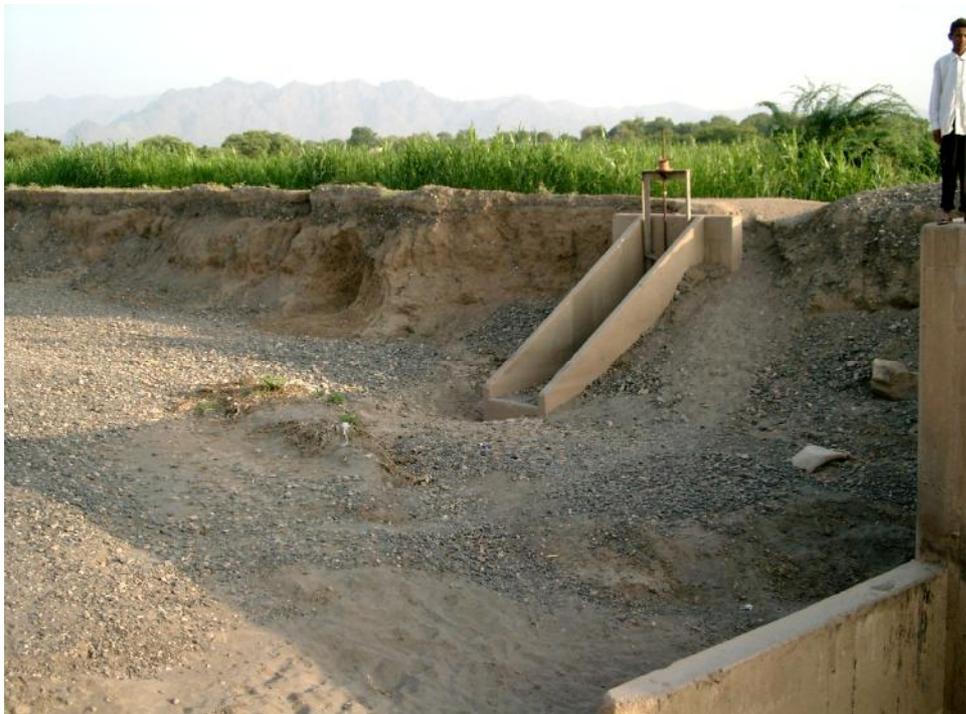
It has been noticed during the walkthrough survey along the Mawi and Mawi-Yusufi canals that severe erosion and weakening of canal banks has taken place, more prominently along the left bank. Moreover deep rain cuts are visible at several places along both the banks. The erosion is more severe immediately downstream of the drop structures. It appears some stone protection

was provided at structures but has been removed by the farmers as they use the stones for checking the water level at the drop structures.

*Eroded Banks of Mari-Yousafi Canal*

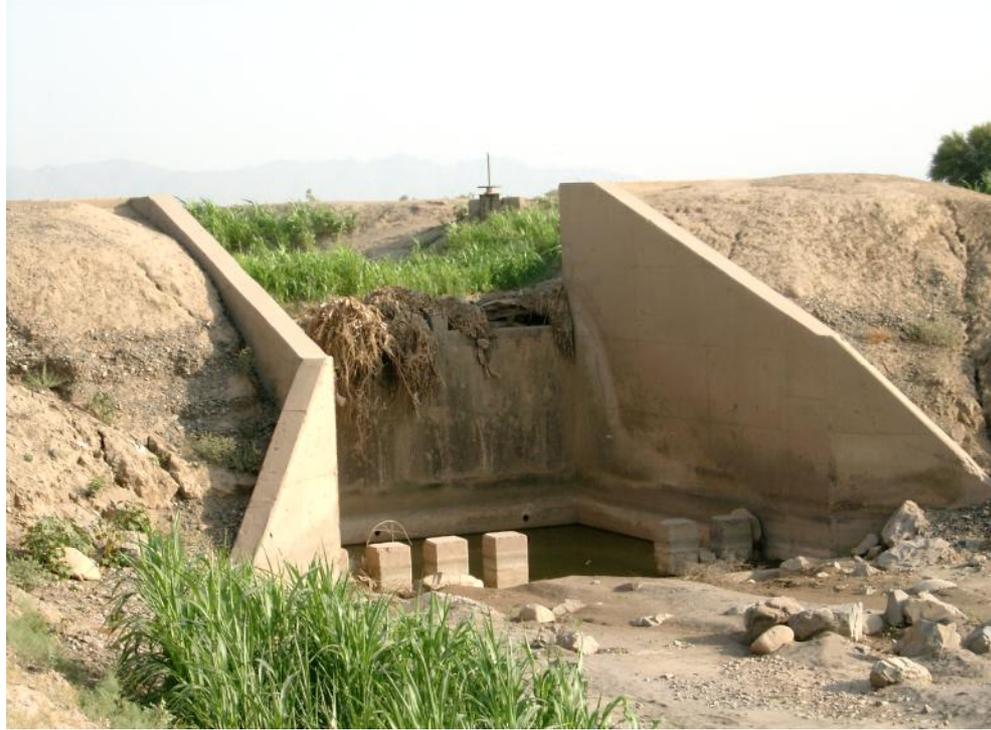
*Damaged Drop Structure*

- The vegetation of both types, sown crops and wild trees, would be removed during annual maintenance and the reconstruction.
- The repair of the damaged chute and baffle blocks would be made part of the construction drawings for transformation of drops into cross regulators while the provision of gates would reduce the risk of similar problems arising in the future.
- Further the downstream ripraps shall be rehabilitated with proper design matching the stone properties with the hydraulic parameters.
- The provision of gates at the drops would eliminate the need to check water there through temporary blockade using stones removed from downstream aprons.
- The repair of the minor rain cuts would be addressed with new strong embankments. However properly designed inlet structures would be required where flooding from fields has damaged the canals.

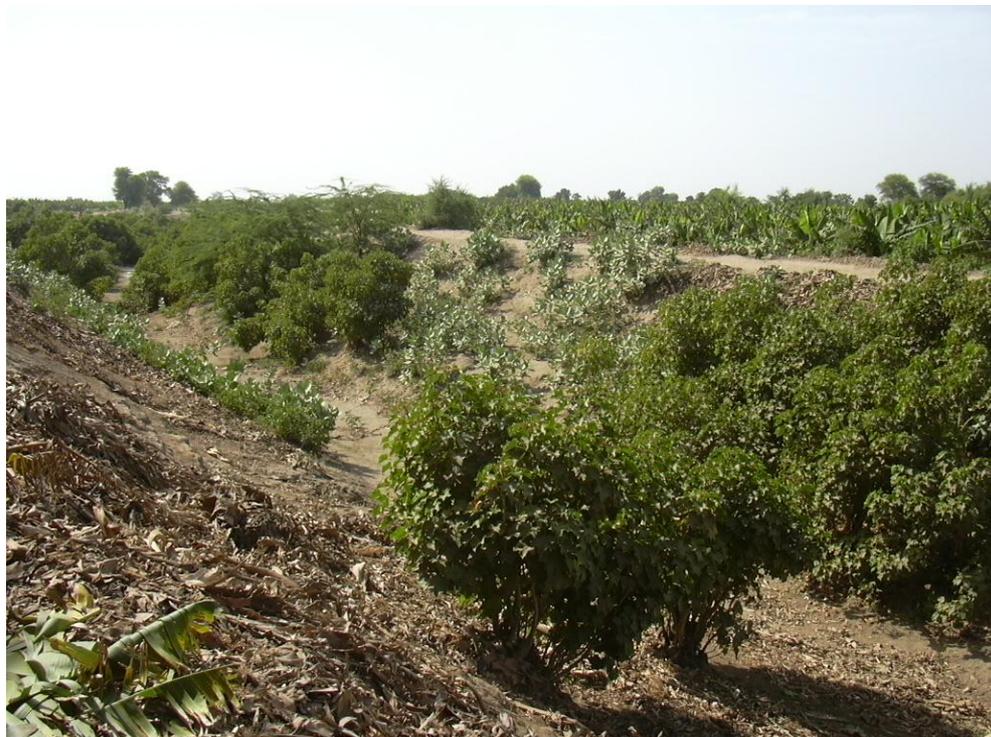
Unlike the canals of diversion weir 3, heavy growth of wild vegetation has been observed along the banks of Mansuri –Rayan and Mansuri canals. This vegetation includes bushes and tall trees with significant girth. This tall vegetation further retards the flow, increases the flow depth and may result in overtopping of the banks.

*Wild Growth of Vegetation in Mansouri-Ryan Canal*

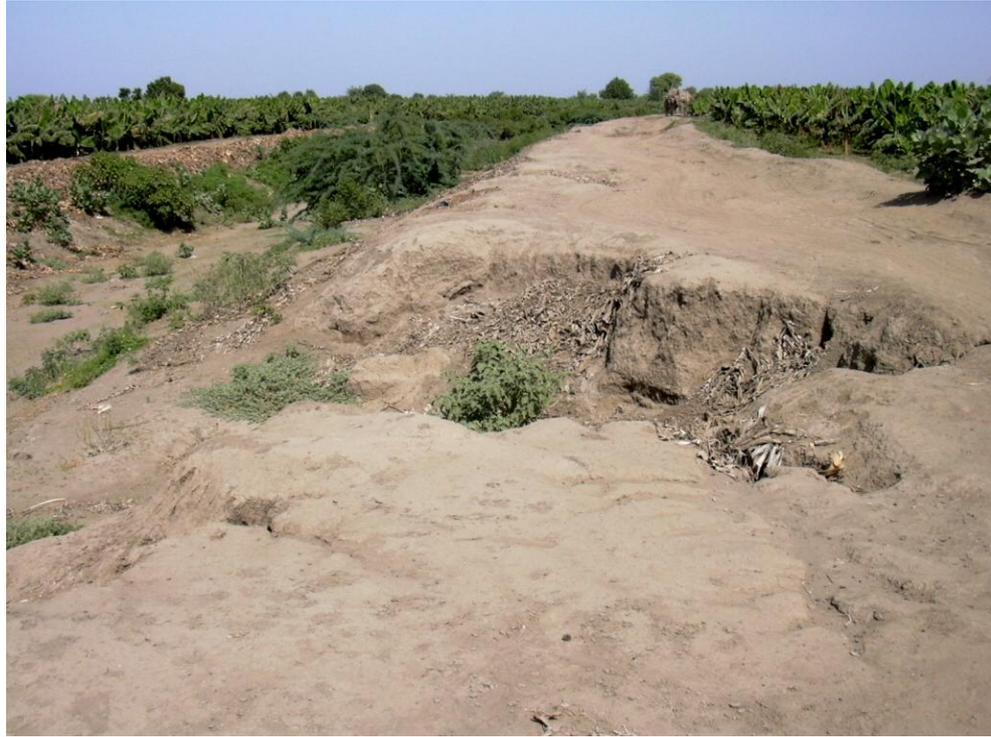
*Deep Incised Cut in Mansuri Canal Bank Due to Flooding*

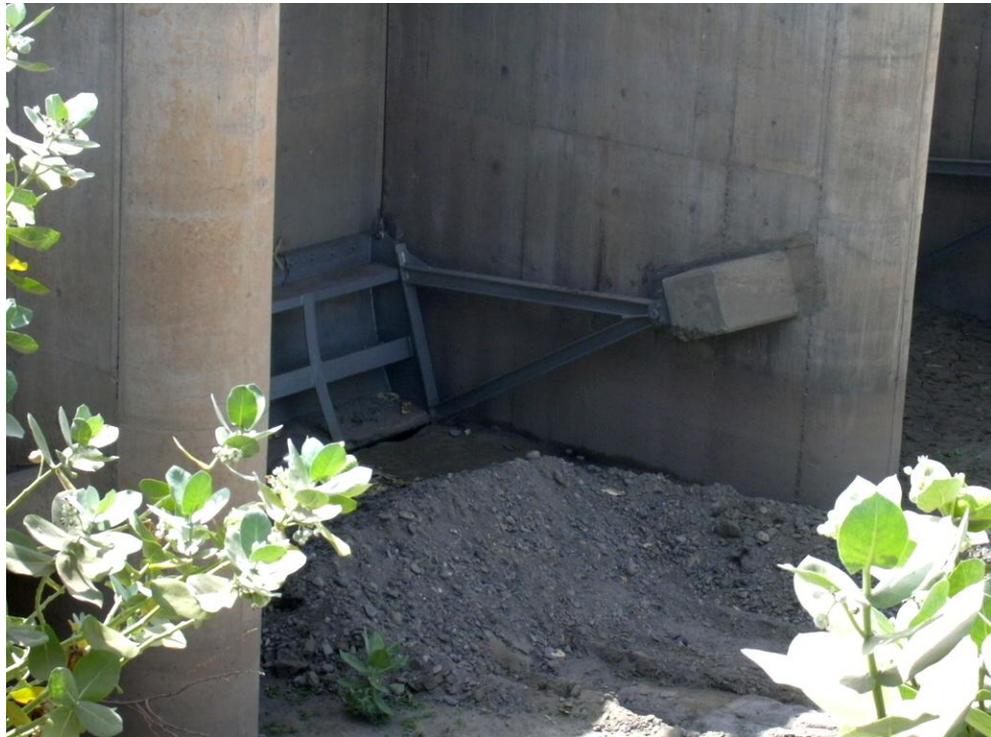
Coarse sediment deposition in the head reach results in significant reduction of the water diverted to the canal, as due to rise in water level in canal the working head is reduced at the head regulator. The head regulators are meant to divert the entire wadi flow up to a certain limit before it starts spilling of the main weir. But as the working head is reduced, water level rises upstream of the head regulator so much so that it rises above the main weir level. This hampers the flow diversion according to the water allocation rules established. In the worst case the sediment deposition in the canal blocks the head regulator.

*Deposited Sediment In Front of Head Regulator*
