IRRIGATION IMPROVEMENT PROJECT

WORKING PAPER 8

Gates Assessment

Interim Report

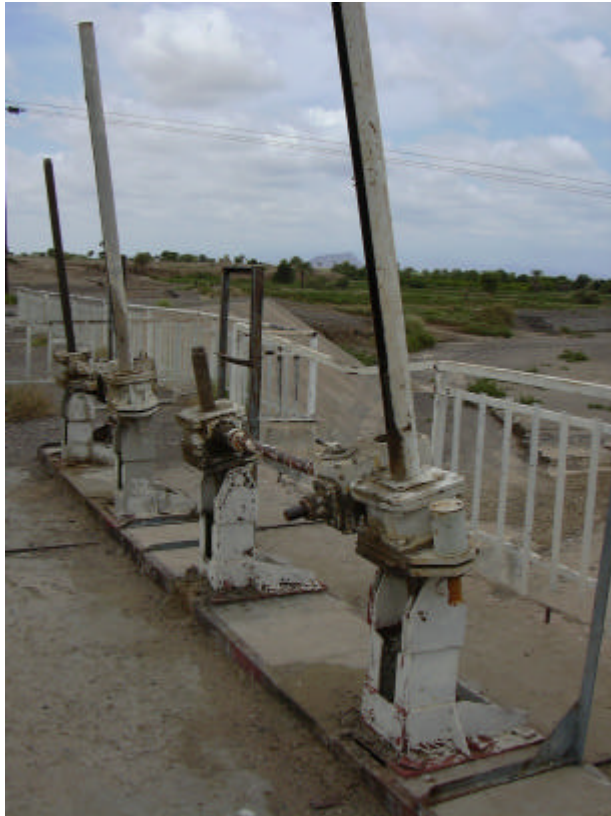
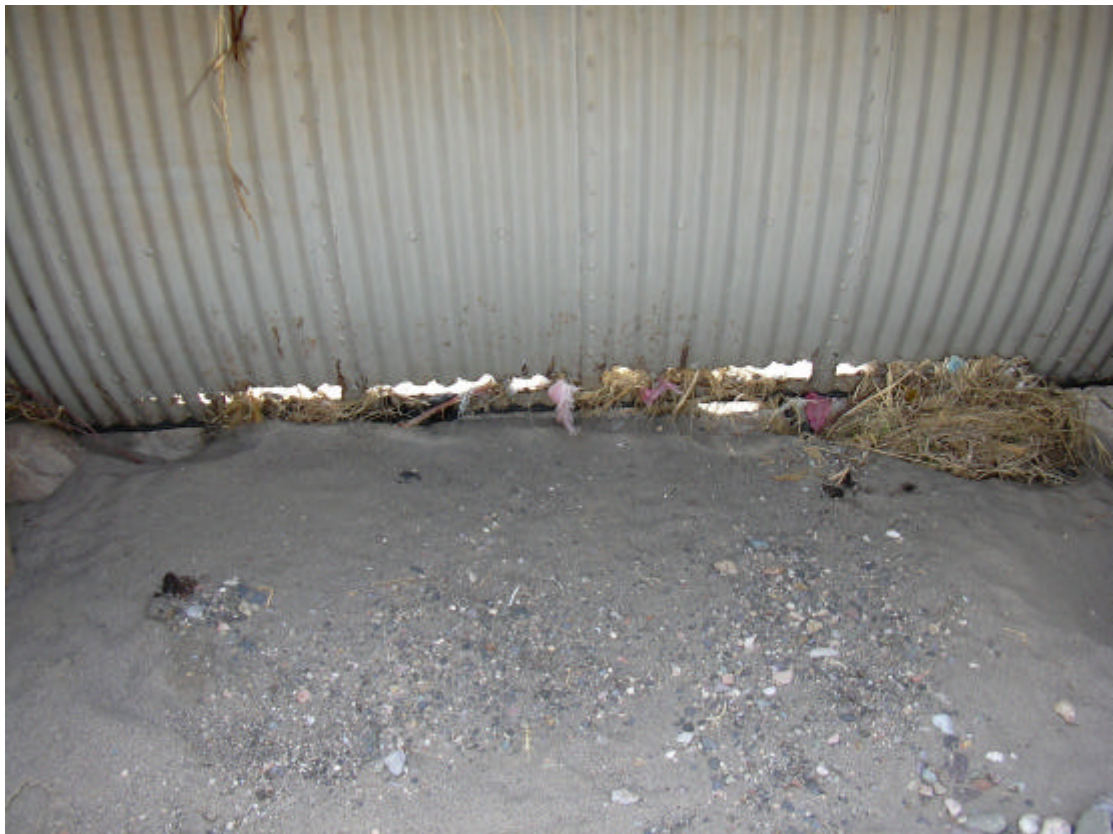
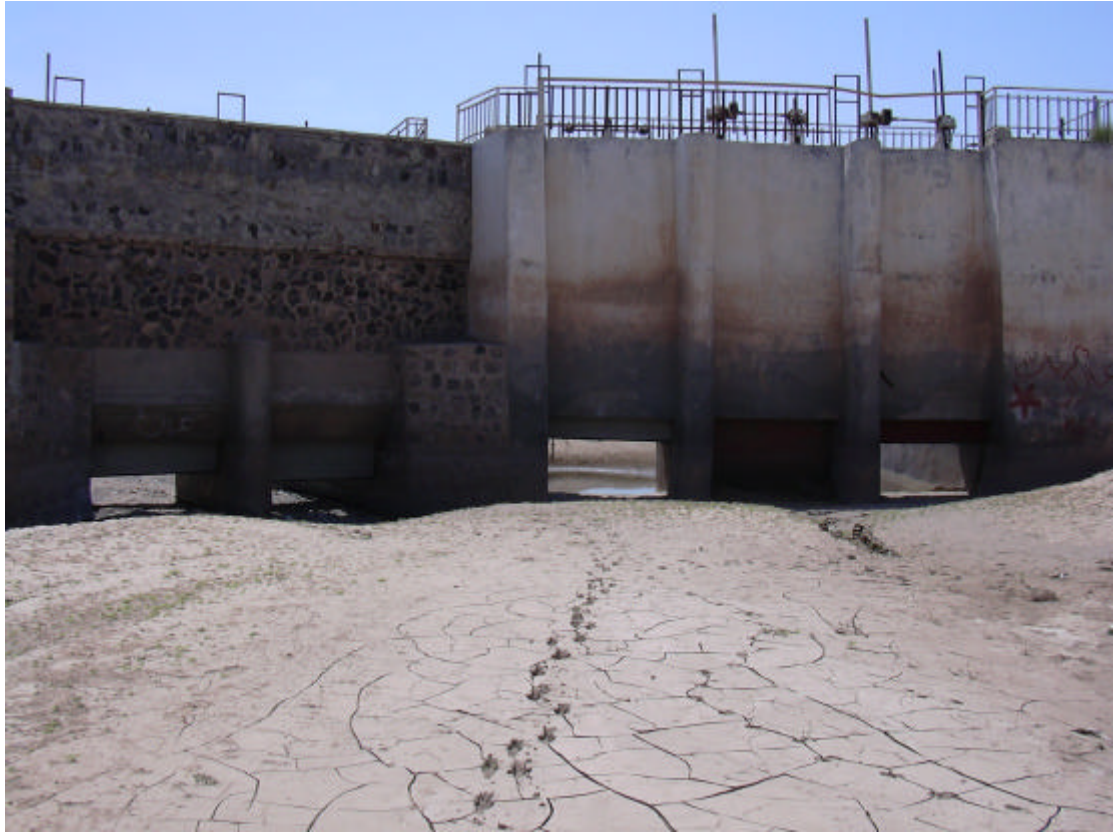
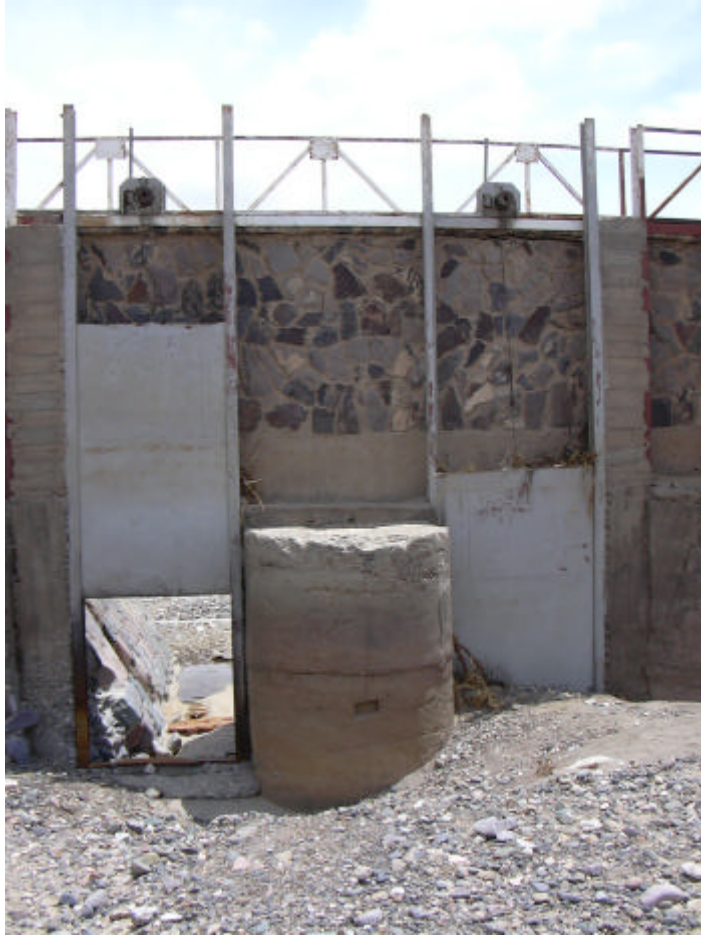
Photographs of Ras al Wadi Weir:

<p>Condition of Gates and Lifting Machinery:</p> <p>Right Bank: The two remaining Russian gate operating machinery is not operational and need to be replaced. The three locally made gates are in operational condition but in need of some minor improvements.</p> <p>Centre Intake: The radial gate (gate no.3) needs a new skin plate; the rest of the structure and lifting mechanism is sound.</p> <p>Vertical gate no.1 (furthest from right bank) has a damaged sill plate that needs repair. Part of gate no.2 was buried in sand; the visible part looked in good condition. Gates 1 and 2 need new wire ropes.</p> <p>Gate no.4 has a missing lifting spindle otherwise appears to be operational.</p> <p>Gate no.5 has a damaged spindle; otherwise appears to be operational.</p>
<p>Recommended Rehabilitation Works:</p> <p>Right bank: Replace the two Russian lifting mechanisms with wire ropes and hand operated winches.</p> <p>Install side-rubbing strips to the sidewalls of all five radial gates.</p> <p>New side and bottom seals for the three local gates.</p> <p>New top seals for all five gates, if agreed.</p> <p>Guards over the gearing for all five lifting mechanisms.</p> <p>Centre Intake: Repair sill beam to gate no.1, new wire ropes for gates 1 & 2, new skin plate for gate no.3, new spindles for gates 4 & 5.</p>

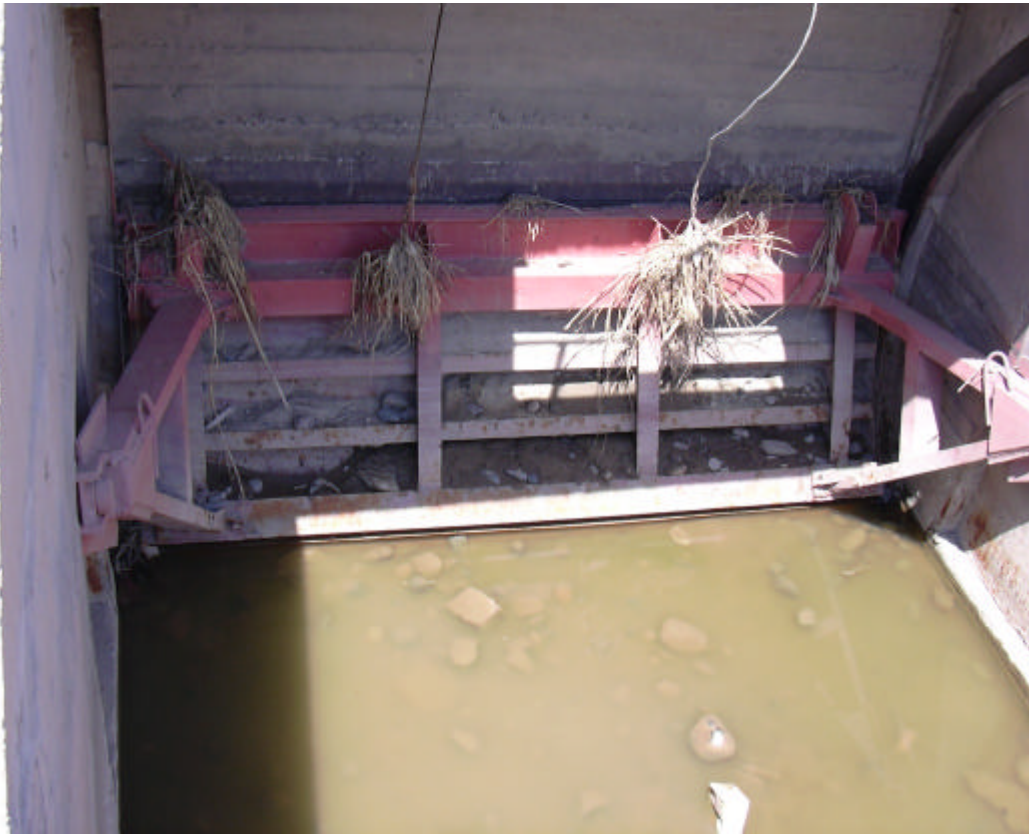
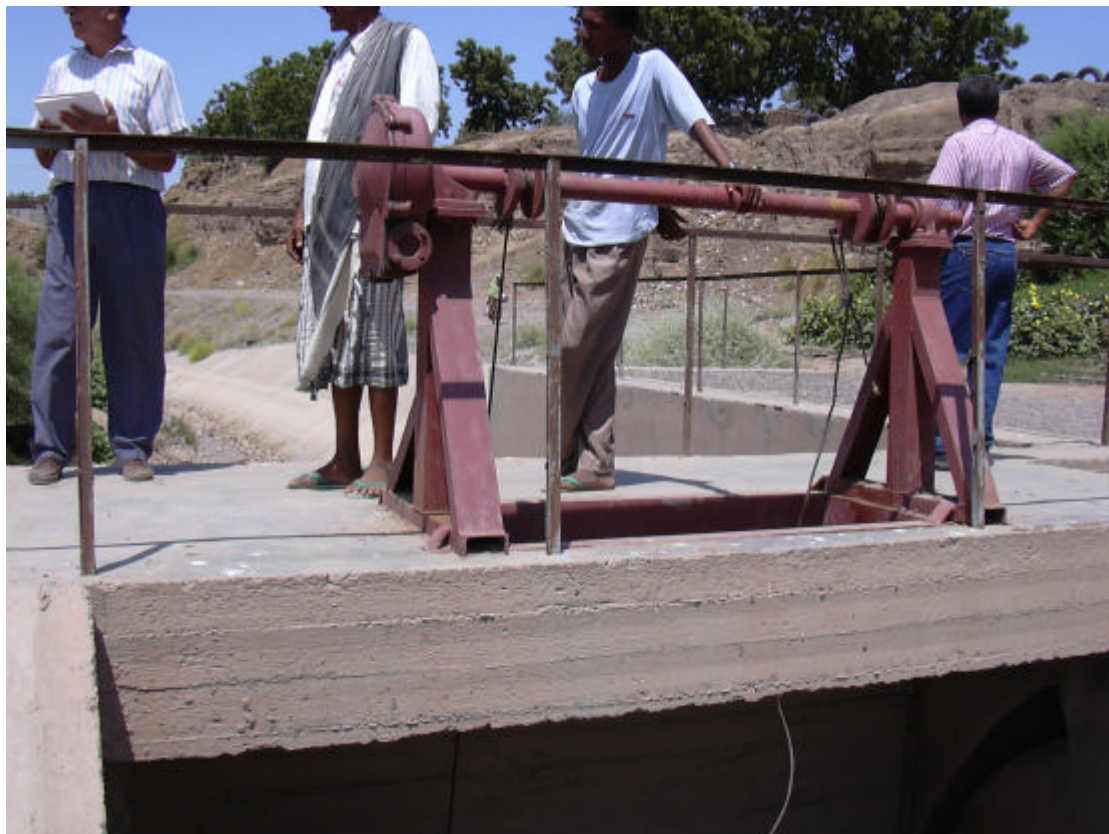
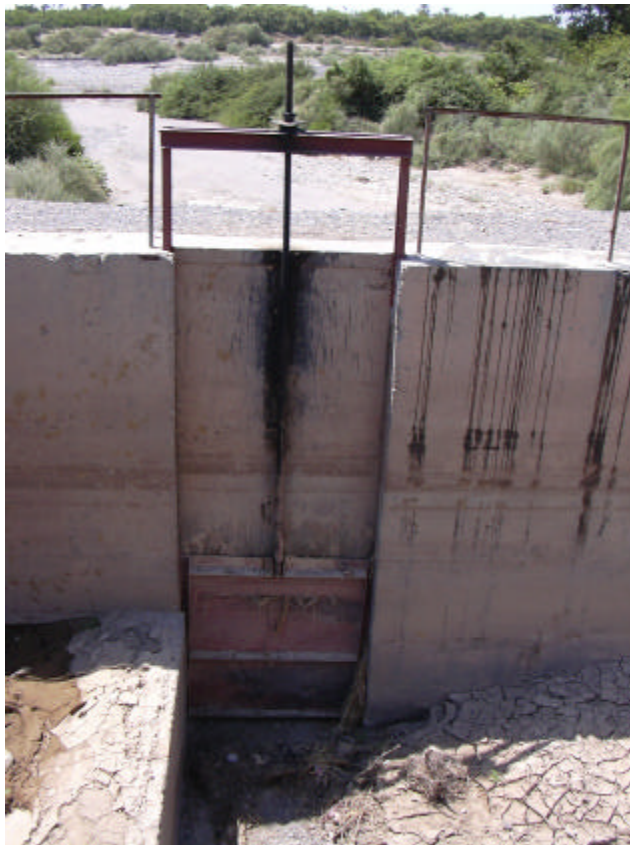
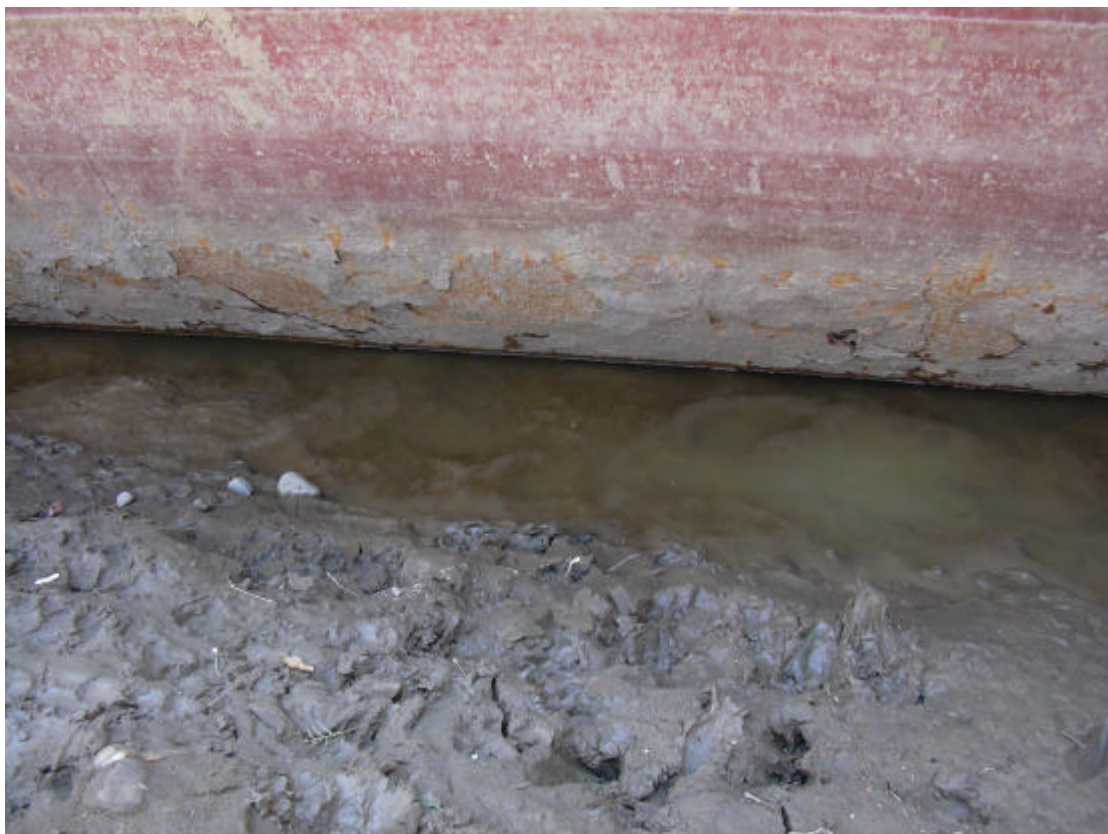
Photographs of Faleg Al Nino Weir:

WADI TUBAN GATE DETAILS – Location Of Structure: Faleg Al Nino Weir
Number/Type of gates: 1 no. radial gate 1 no. vertical sluice gate
<p>Description of gates:</p> <p>The Russians constructed the control structure around 1974.</p> <p>Radial Gate: The gate is retained within grooves cast into the sidewalls. Dimensions are 3.62m wide x 1.45m wide x 1.52m radius. A single winch drives a horizontal shaft with two wire rope drums. The wire rope is a single rope that passes from one drum down to the top of the gate across the gate and up to the other drum. The gate is of solid construction and is structurally sound.</p> <p>Vertical Sluice Gate: Nominal dimension are 1.52m wide x 1.55m high. 50mm shaft diameter, 3.85m shaft length, height from bottom of gate to top of concrete structure is approx 4m. The gate is installed over a rectangular culvert. Poor quality local manufacture.</p>
<p>Condition of Gates and Lifting Machinery:</p> <p>Radial: No maintenance has been carried out for a considerable time. No drain holes in lower horizontal stiffener resulting in trapped sediments and corrosion of the skin plate. The wire rope was broken and was temporarily fixed on one side only to enable it to be lifted. The rope fouls the concrete. The open mesh grating under the winding mechanism was missing.</p> <p>Vertical Sluice: The gate appeared to be in good operational condition. The shaft was well lubricated.</p>

<p>Recommended Rehabilitation Works:</p> <p>Radial: Overhaul winch gearbox, refill with grease. Provide new wire rope with sufficient length for three spare turns on rope drums when gate is fully lowered. Wire rope to be correctly clamped at rope drums. Replace missing floor grating. Provide large diameter drain holes in lower horizontal stiffener. Replace top, bottom and side seals. Grit blast and repaint. Lubricate pivot bearings.</p> <p>Vertical Sluice: Remove existing gate and frame and replace complete assembly.</p>
Cost Estimate:

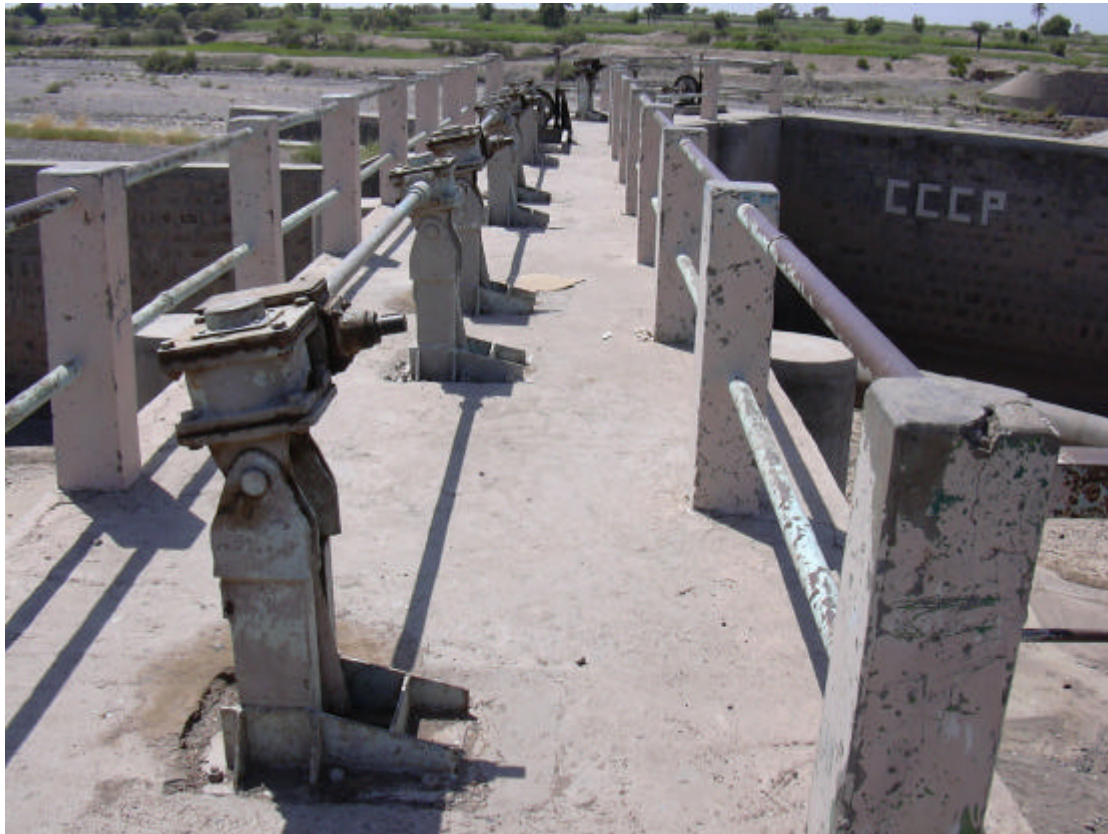
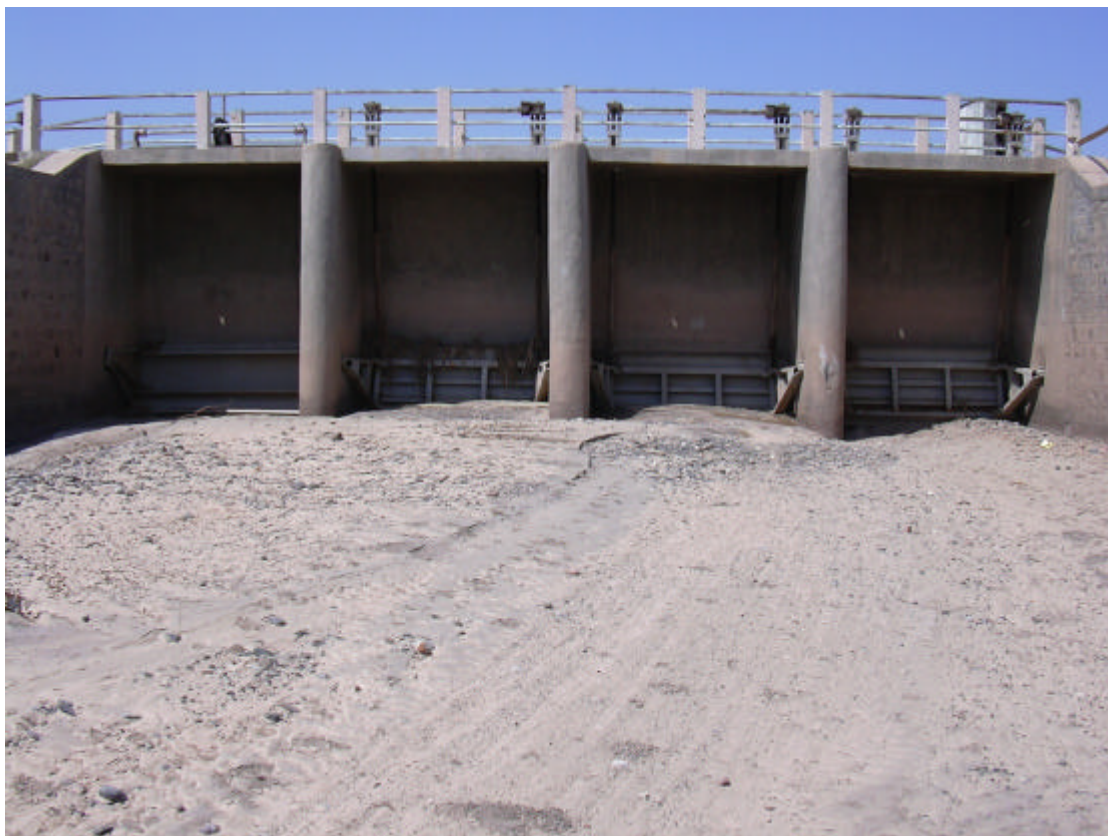
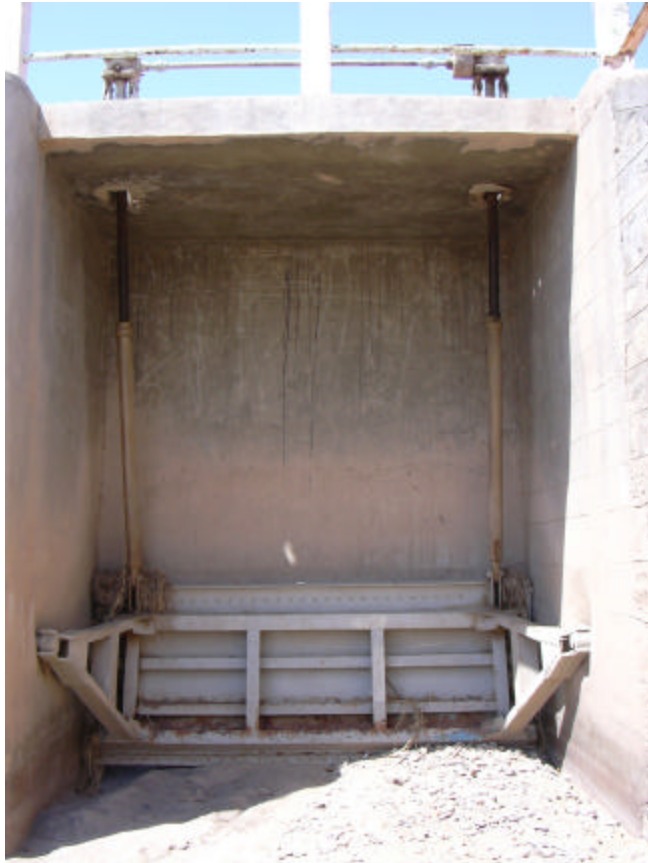
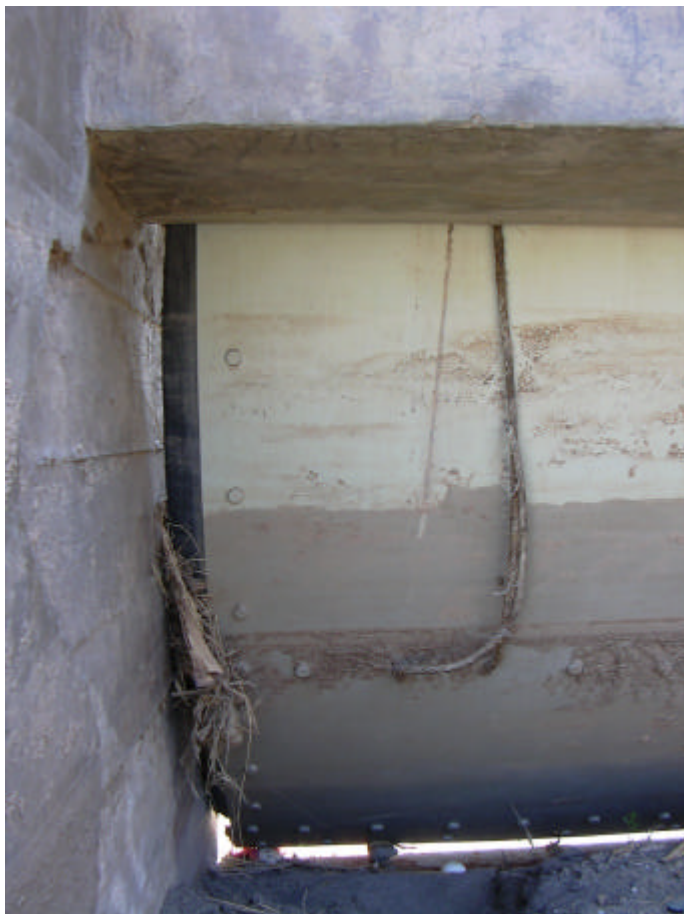
Photographs of Faleg Al Aiad Weir:

<p>Condition of Gates and Lifting Machinery:</p> <p>The remaining Russian gates and associated lifting machinery appear to be in operational condition. The bottom of the gates is embedded in sand and stones and is currently unable to be moved. The locally made gates are in good operational condition although one of the wire ropes on the smaller gates is damaged.</p>
<p>Recommended Rehabilitation Works:</p> <p>Russian gates: Remove all sand and stones from around bottom of gates. Make large diameter holes in bottom stiffeners, fit new side and bottom seals, remove local areas of corrosion and repaint gates. Completely overhaul lifting mechanisms or alternatively replace the mechanisms with wire ropes and winches.</p> <p>Local gates: Replace broken wire rope; install guards over open gears.</p>
Cost Estimate:

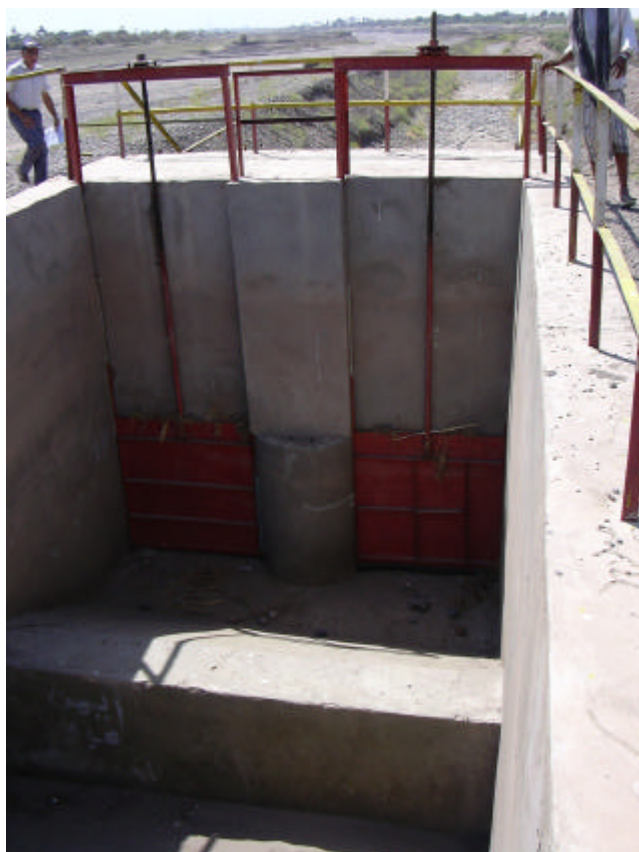
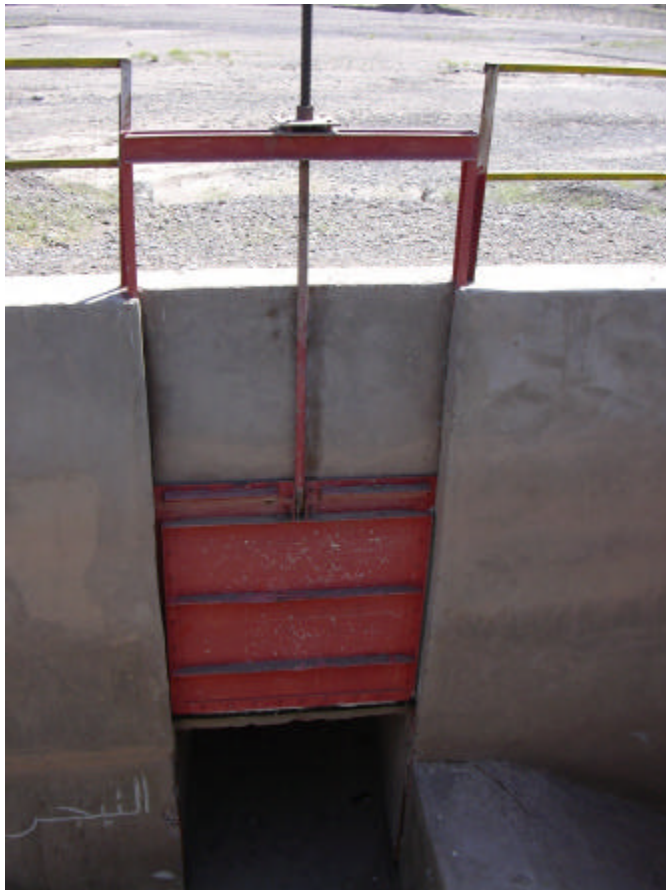
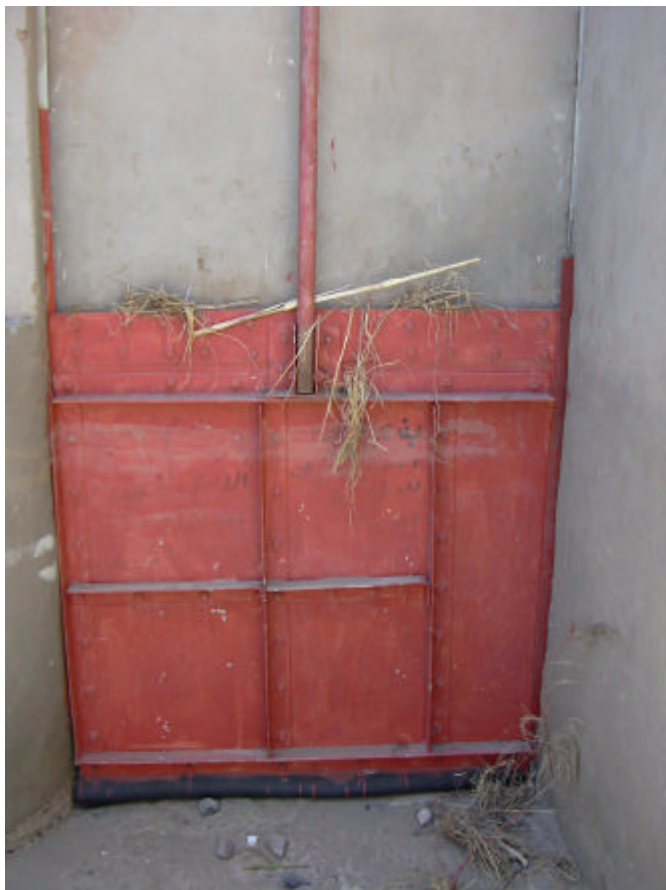
Photographs of Al Khabet Weir:

WADI TUBAN GATE DETAILS – Location Of Structure: Al Khabet Weir
Number/Type of gates: 3 no. vertical sluice gates
<p>Description of gates:</p> <p>Nominal dimensions: 1.55m wide x 1.55m high. Standard vertical spindle design. Installed within last 5 years.</p>
<p>Condition of Gates and Lifting Machinery:</p> <p>The three gates are in operational condition. One gate has a slightly bent spindle. The thrust bearing fixing bolts on one side do not align with the cross member and have not been drilled. Poorly designed and installed.</p>
<p>Recommended Rehabilitation Works:</p> <p>Straighten the bent spindle. (1 no. gate) Replace thrust bearing retaining plates, properly drilled to suit cross beam.</p>
Cost Estimate:

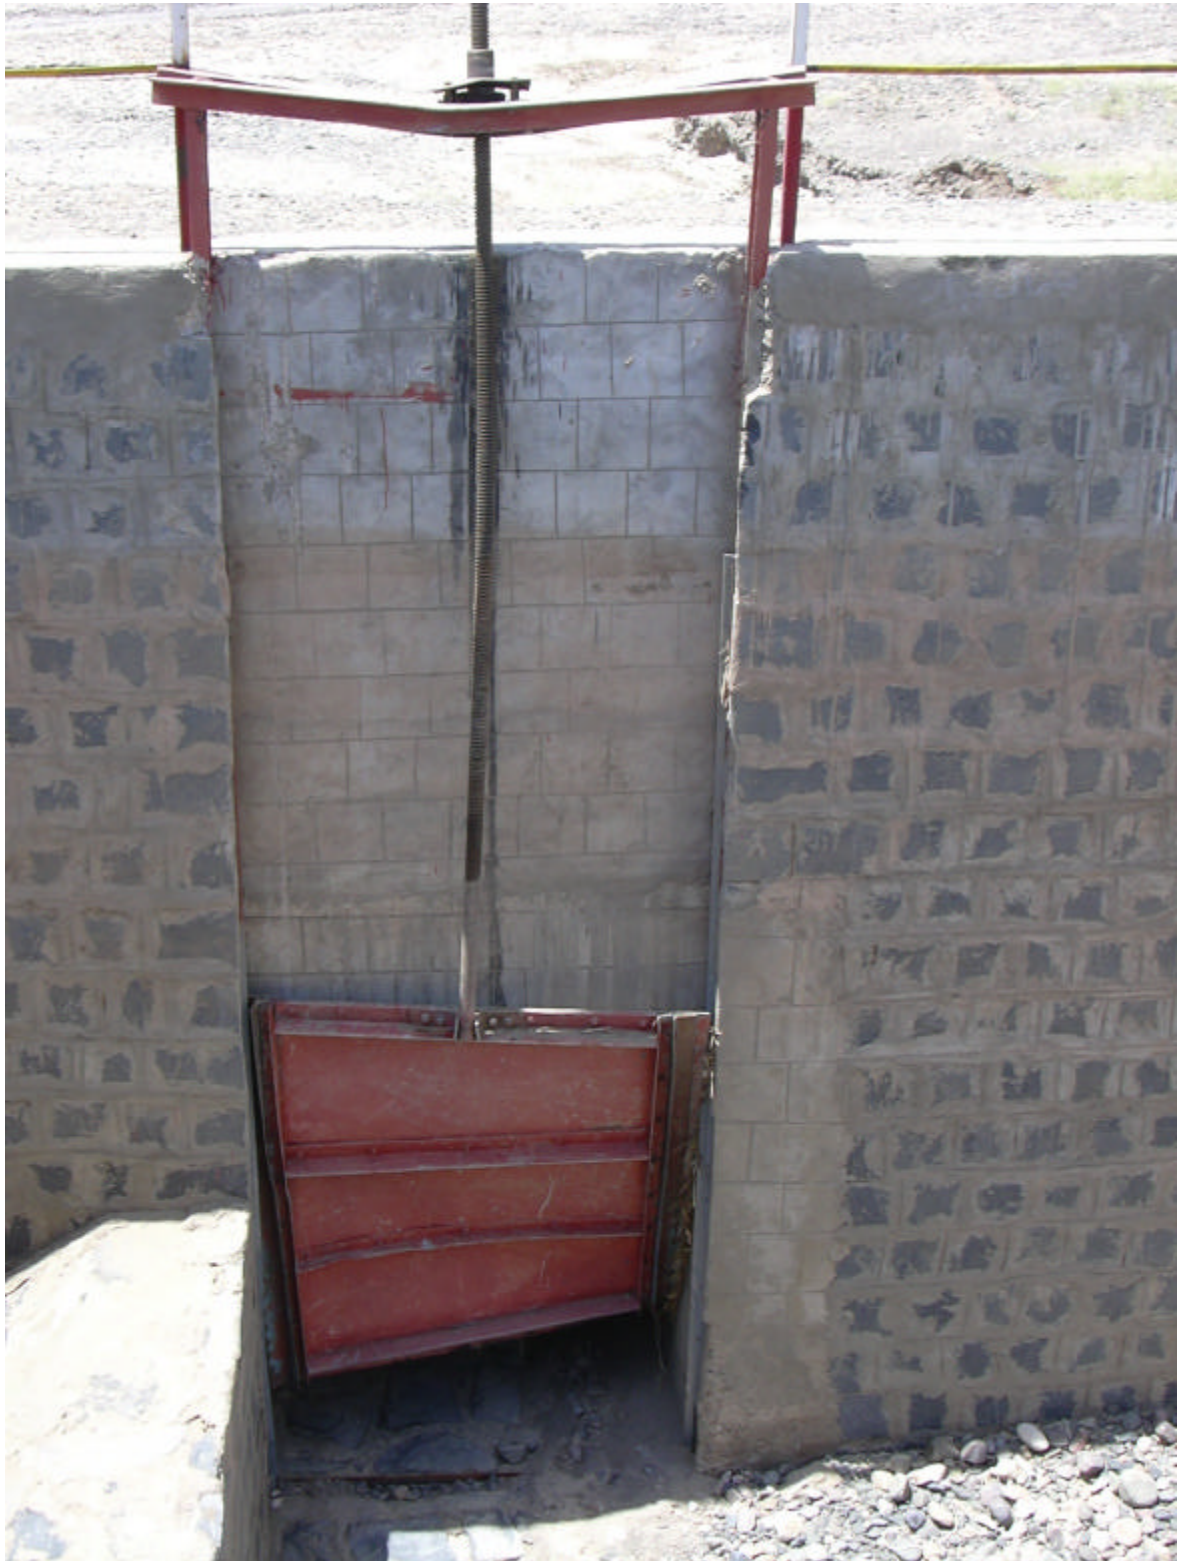
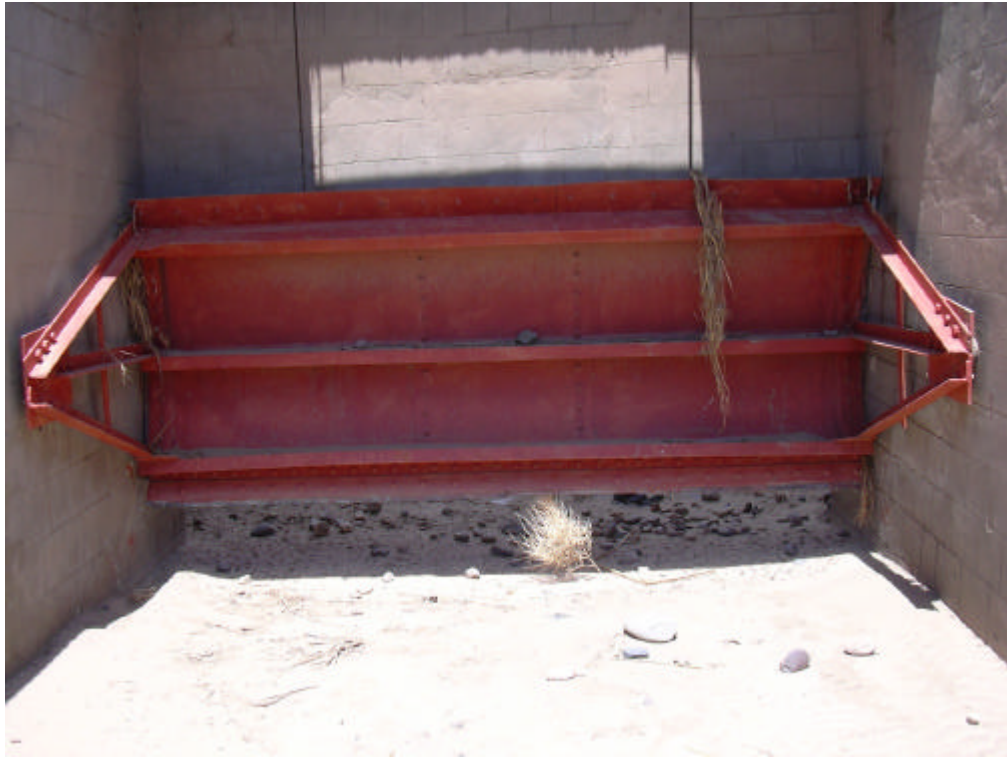
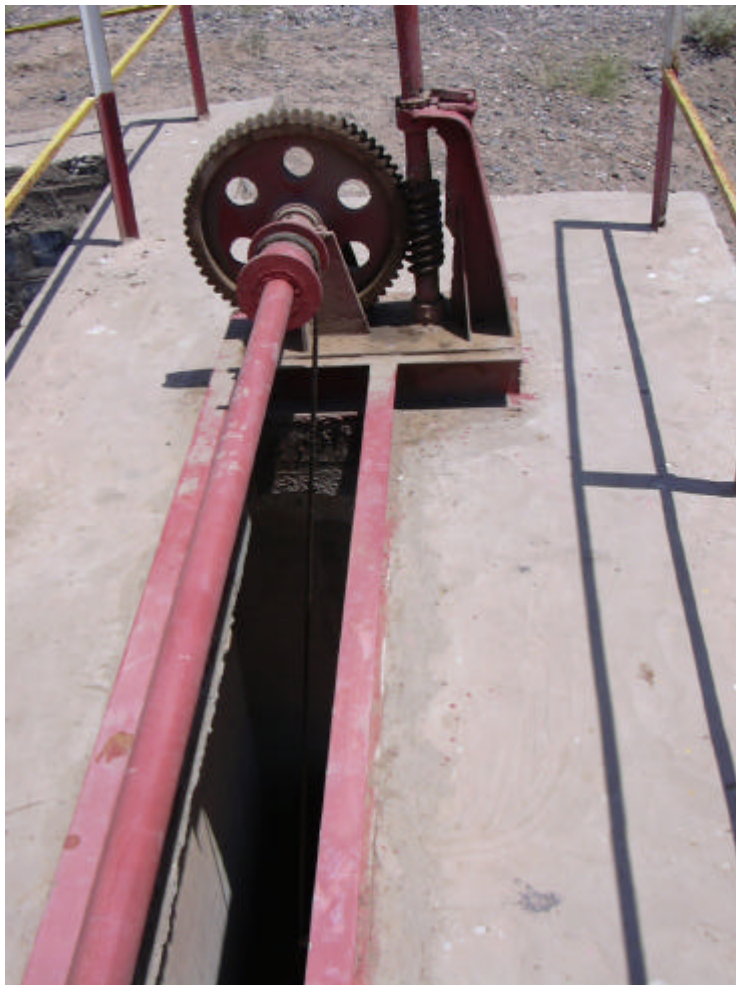
Photographs of Al Fakeel Weir:

WADI TUBAN GATE DETAILS – Location Of Structure: Al Fakeel Weir
Number/Type of gates: 1 no. radial gate 1 no. vertical sluice gate
<p>Description of gates:</p> <p>Radial: Nominal dimensions: 3.6m wide x 1.5m high x 1.44m radius. The gate was locally made and installed within the last 5 years. The gate is raised by two wire ropes attached to drums mounted on a horizontal shaft driven by a manually operated worm gear winch.</p> <p>Vertical Sluice: Nominal dimensions: 1.5m wide x 1.6m high. Standard vertical spindle design. Recently installed.</p>
<p>Condition of Gates and Lifting Machinery:</p> <p>The radial gate and winch are in good operational condition. The side seals are extruded through the side gaps. There is a variable tapered side gap on both sides. The sidewalls do not appear to be vertical.</p> <p>The water pressure has pushed the vertical sluice gate inside the culvert, distorting the gate slide, buckling the guide frame and bending the spindle. The angle side guides were not welded adequately or supported sufficiently and have collapsed under the water pressure.</p>

<p>Recommended Rehabilitation Works:</p> <p>Radial: Install side rubbing strips to the sidewalls, fit a guard over the open gears, fit new grease nipples (3 no.)</p> <p>Vertical Sluice: Remove the gate slide plate, angle guides inside the channel guides, top cross beams and spindle. Weld new angle guides inside the channel guides as per the drawing for the standard replacement gate. Straighten the spindle and re-use if possible. Fit new slide plate and cross beams(as per standard design). Ensure that the existing guide channels are completely encased in concrete over the three sides.</p>
Cost Estimate:

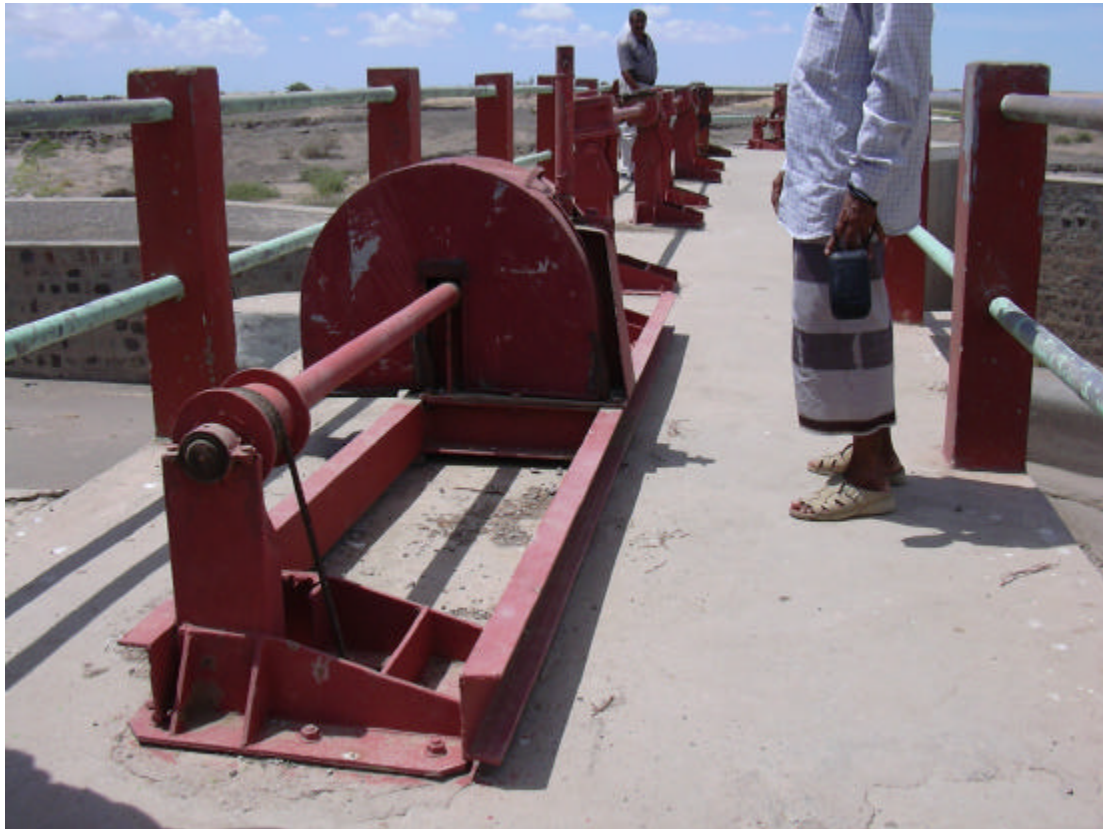
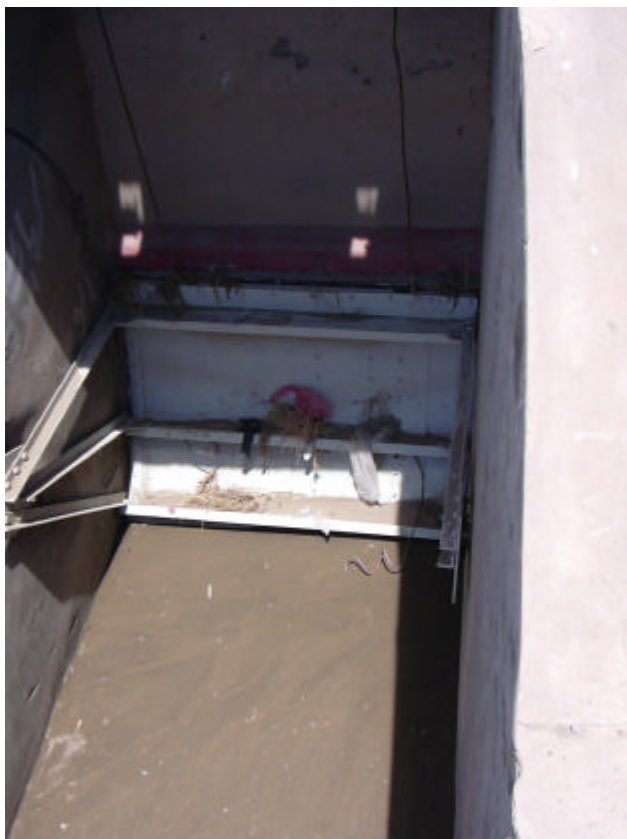
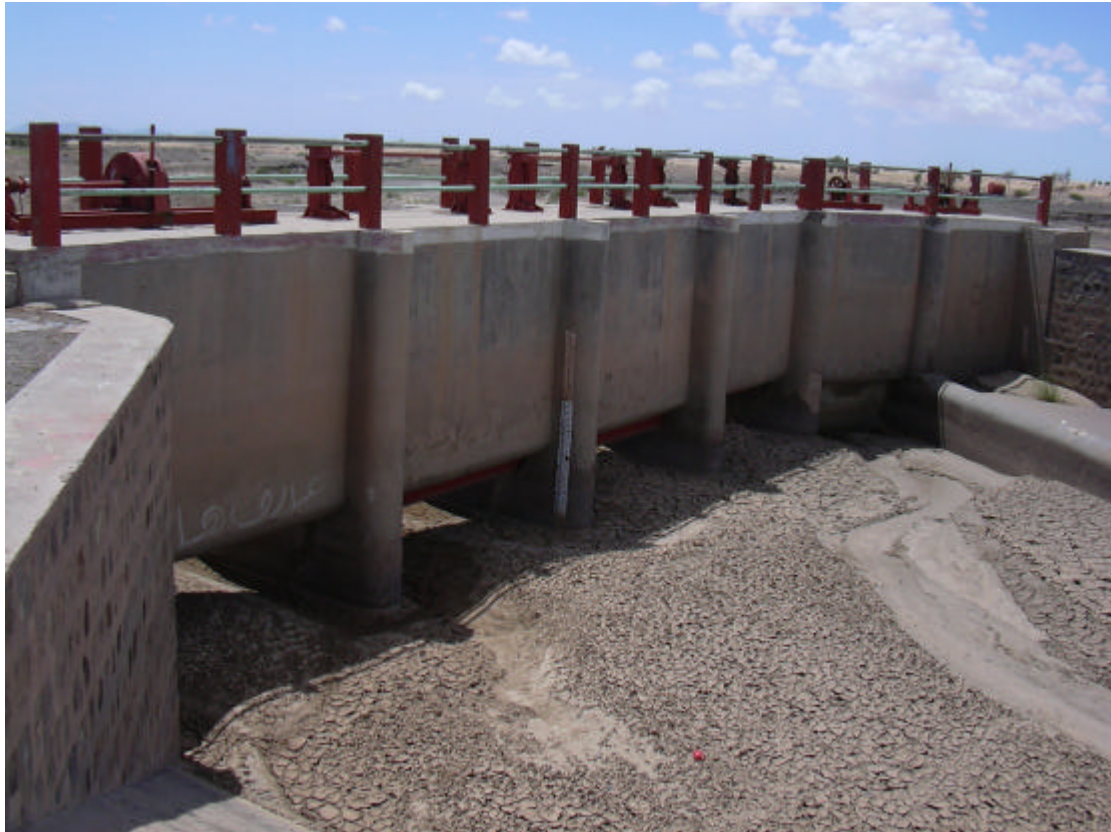
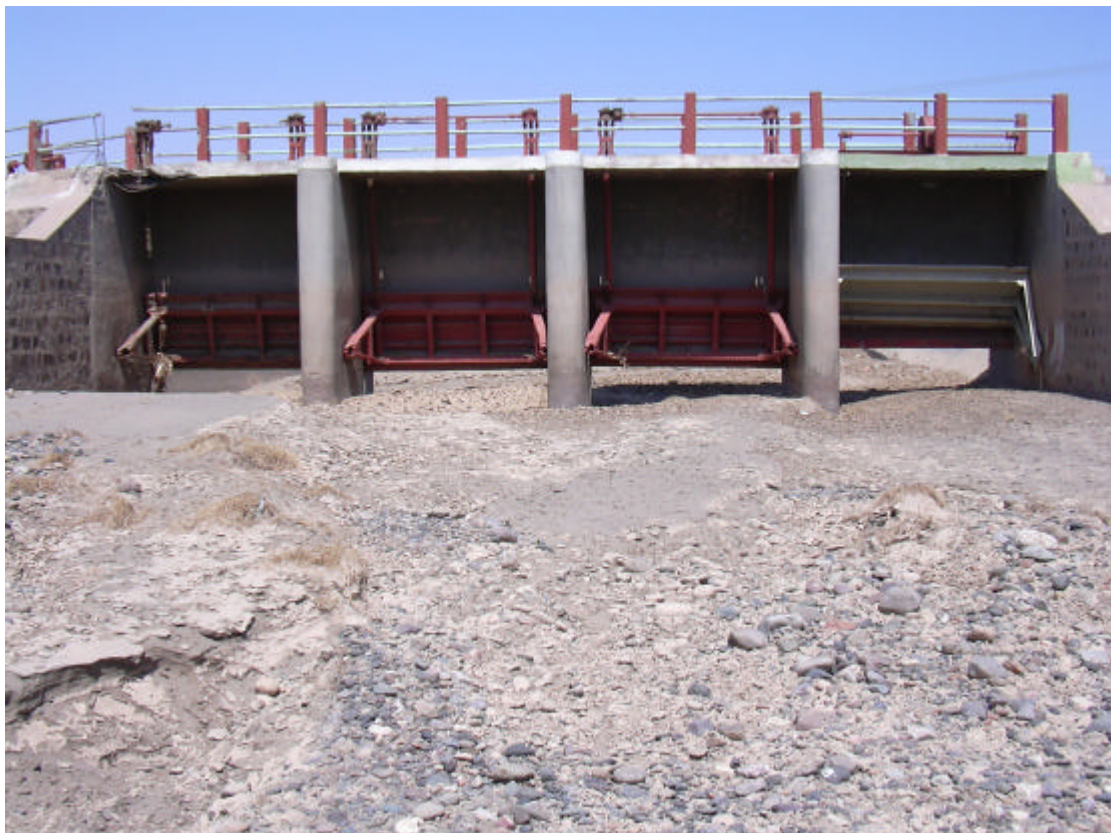
Photographs of Mujahid Weir:

WADI TUBAN GATE DETAILS – Location of Structure: Mujahid Weir
Number/Type of gates: 6 no. radial gates
<p>Description of gates:</p> <p>The Russians constructed the weir in 1971. Two smaller gates 2.4m wide x 1.58m high x 1.92m radius and four larger gates 3.57m wide x 1.39m high x 1.55m radius. One of the larger gates and both of the smaller gates were replaced in 1998 with locally made gates and lifting mechanisms.</p>
<p>Condition of Gates and Lifting Machinery:</p> <p>Smaller gates (nos. 5 and 6) appear to be in good operational condition although gate no.6 is partially buried in deep sand and cannot be lifted. The worm gear for gate no. 6 has been slightly damaged, possibly overloaded.</p> <p>Gate no.4 (Russian design) is not operational and has not been maintained and is beyond repair. The concrete close to the lifting mechanism has been damaged and needs repair. Gates 2 and 3 (Russian) are in operational condition but in need of maintenance. The bevel gearbox cover plates are missing. The gates currently cannot be fully raised as the gates foul the sidewalls. The threaded rod that lifts the gates also fouls the concrete. Gate no. 1 (local) is operational, a guard has been installed over the open gears.</p>

<p>Recommended Rehabilitation Works:</p> <p>Gates 2 and 3: Completely overhaul lifting mechanisms, make large holes in lower horizontal stiffeners, adjust gates to enable them to lift fully, remove concrete locally as required.</p> <p>Gate 4: Remove existing gate and lifting mechanism, repair concrete, install new locally made gate and lifting machinery.</p> <p>Gates 5: Fit cover to open gears. Gate 6: Repair worm gear assembly, fit cover to open gears.</p> <p>Install side-rubbing strips to all gates. Fit new seals and new wire ropes.</p>
Cost Estimate:
