IRRIGATION IMPROVEMENT PROJECT

WORKING PAPER 8

Gates Assessment

Interim Report

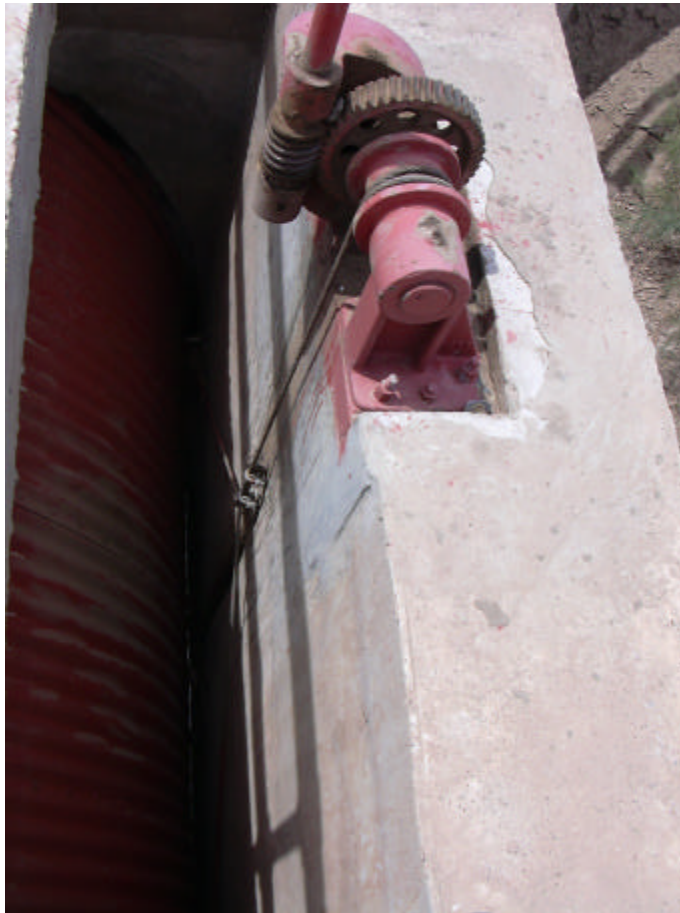
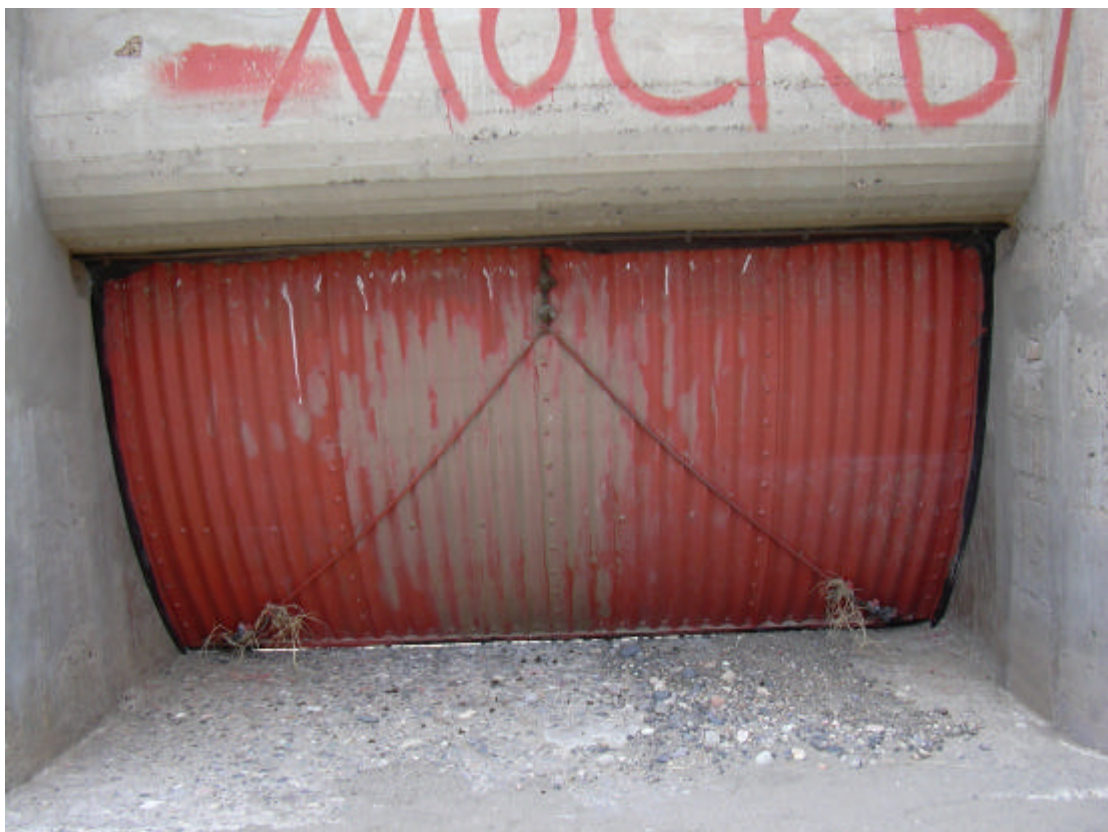
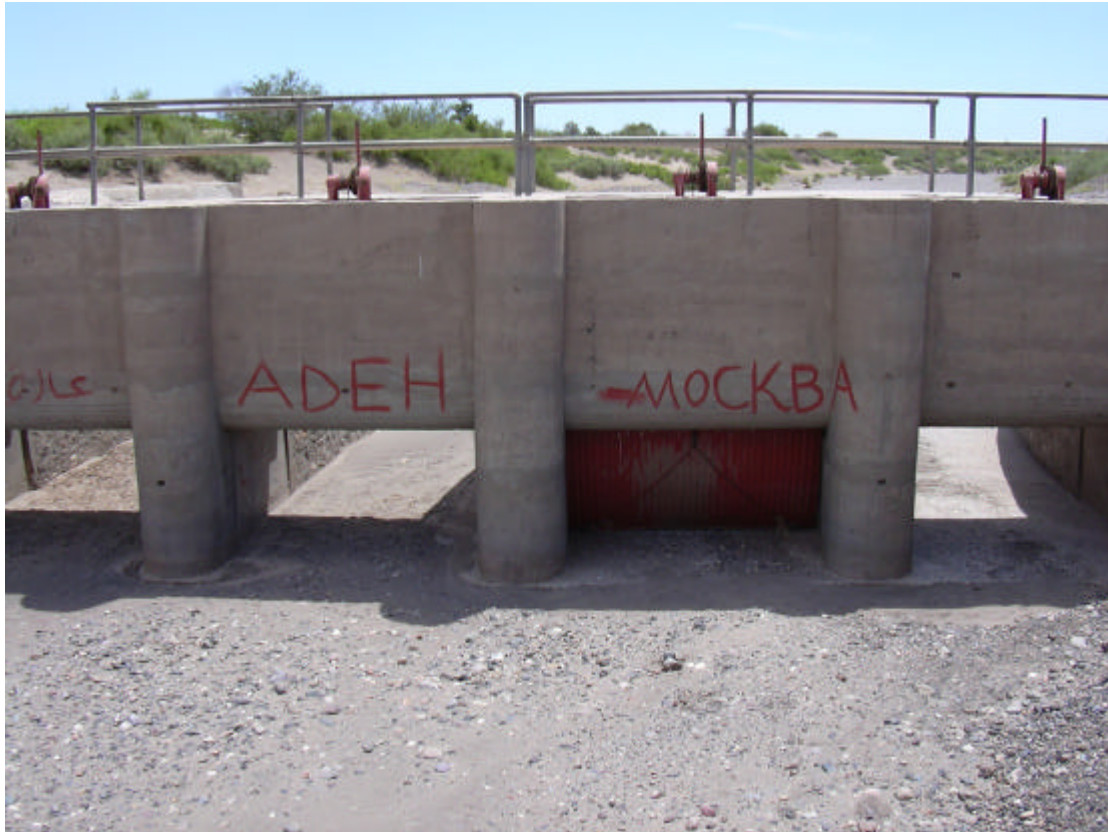
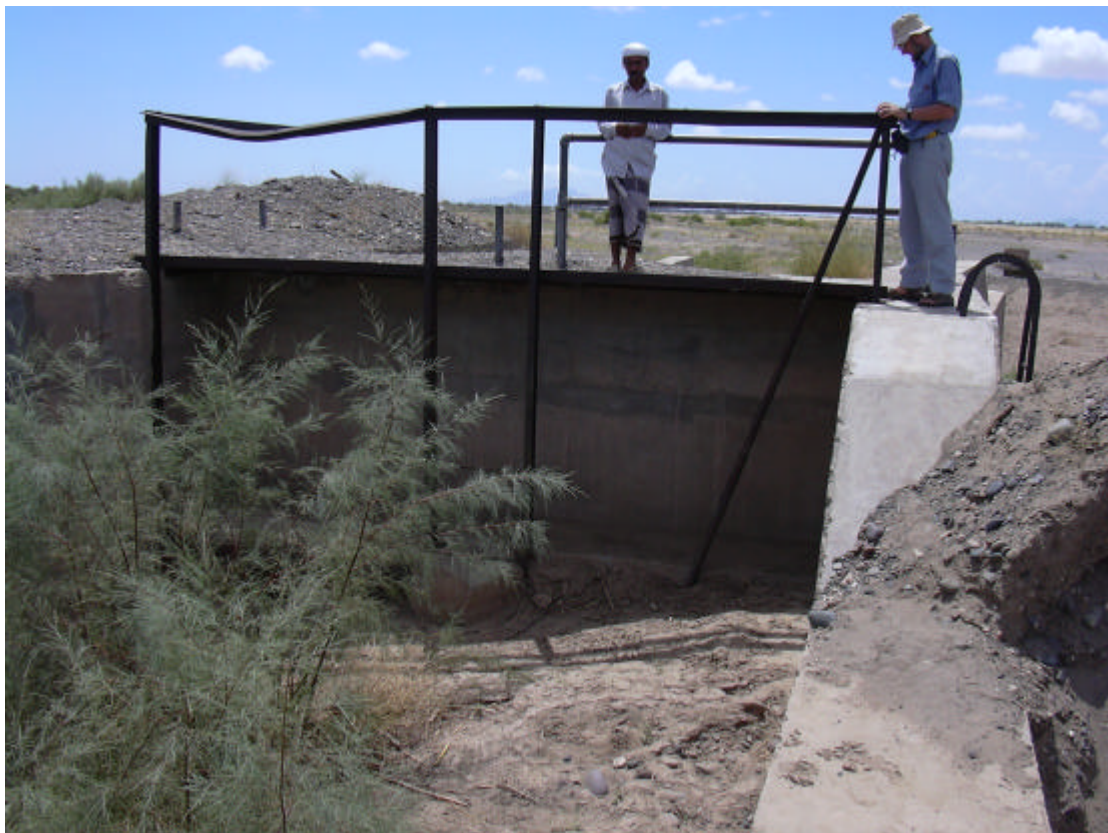
Photographs of Al Wahat Weir:

WADI TUBAN GATE DETAILS – Location Of Structure: Al Wahat Weir
Number/Type of gates: 4 no. radial gates 2 no. vertical sluice gates
<p>Description of gates:</p> <p>The weir was constructed in 1963. British made Armco radial gates were installed. The nominal dimensions are imperial sizes: 8' x 4'6" x 5' (2.4m wide x 1.4m high x 1.5m radius). The radial gates have lightweight corrugated skin plates. The lifting mechanism is a single worm gear driving a wire rope drum with a single point of lift for each gate.</p> <p>The vertical sluice gates are 2.1m wide. The depth could not be measured as the gates are buried in sand.</p>
<p>Condition of Gates and Lifting Machinery:</p> <p>The radial gates and lifting mechanisms are in good operational condition. The vertical sluice gates are buried in sand. The crossbeam has buckled.</p>
<p>Recommended Rehabilitation Works:</p> <p>The lifting mechanisms need to be overhauled and cleaned. New guards and grease nipples are required for the winches.</p> <p>The vertical sluice gates need to be replaced with new gates. (Need to review if these gates are necessary).</p>

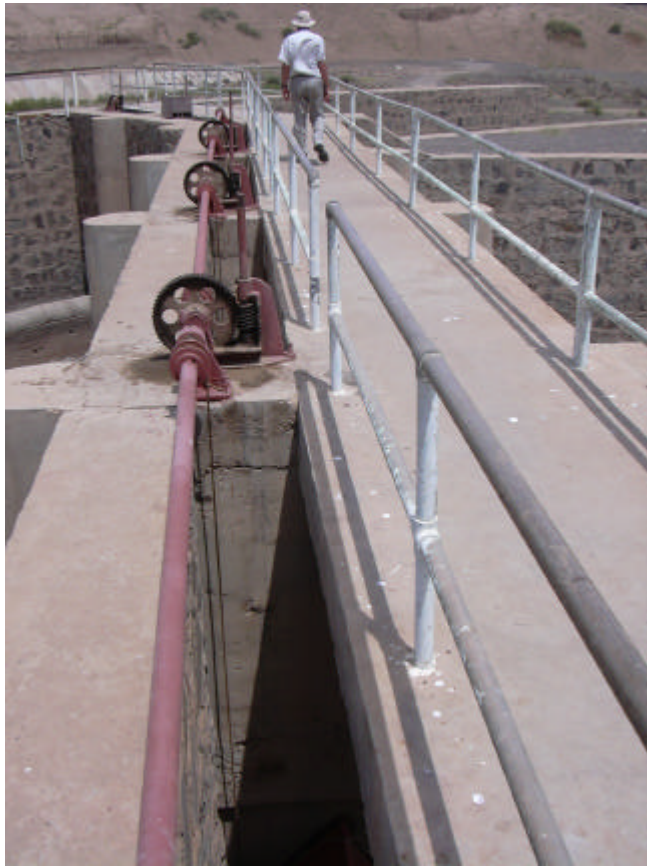
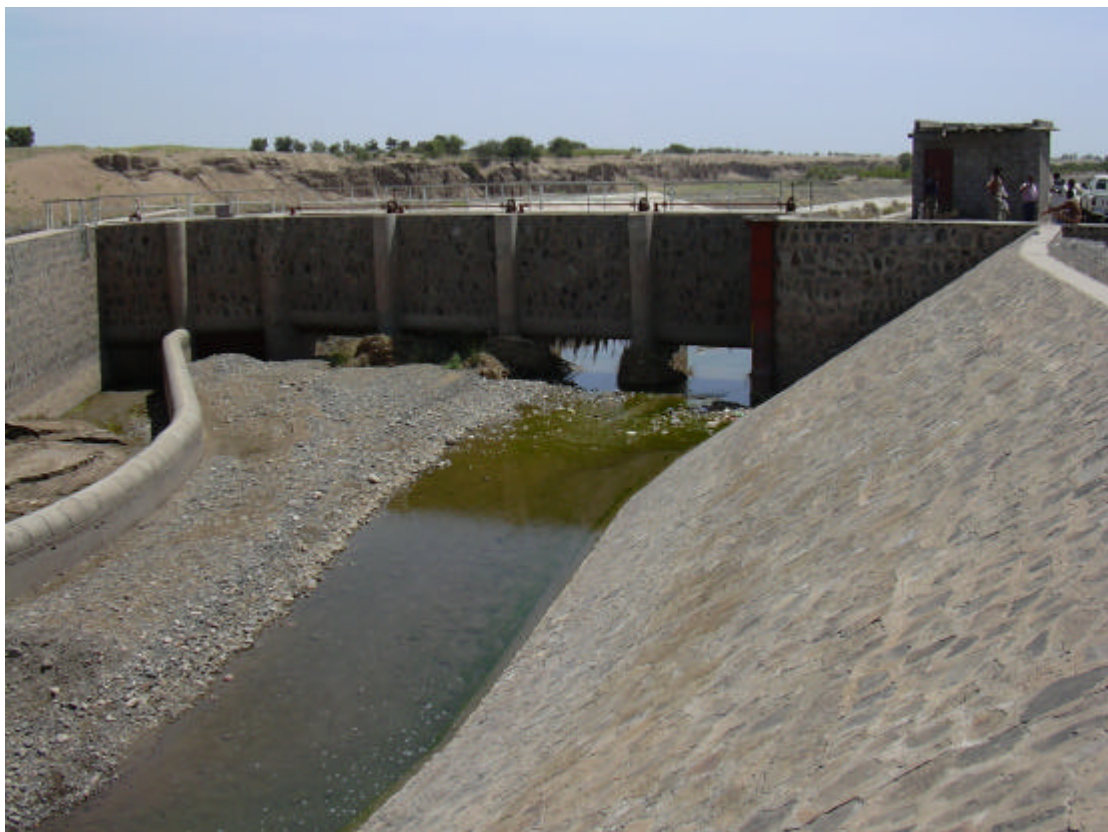
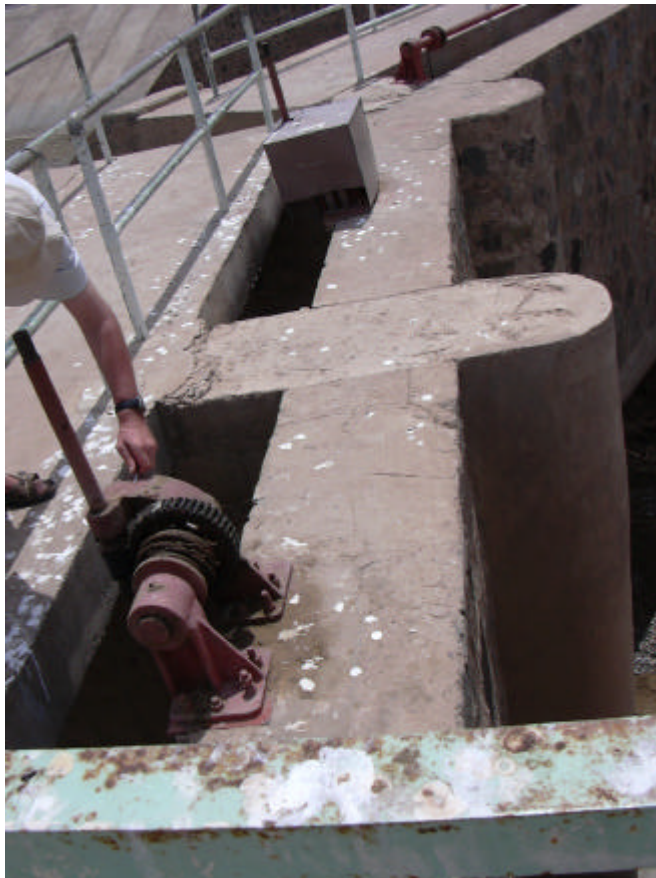
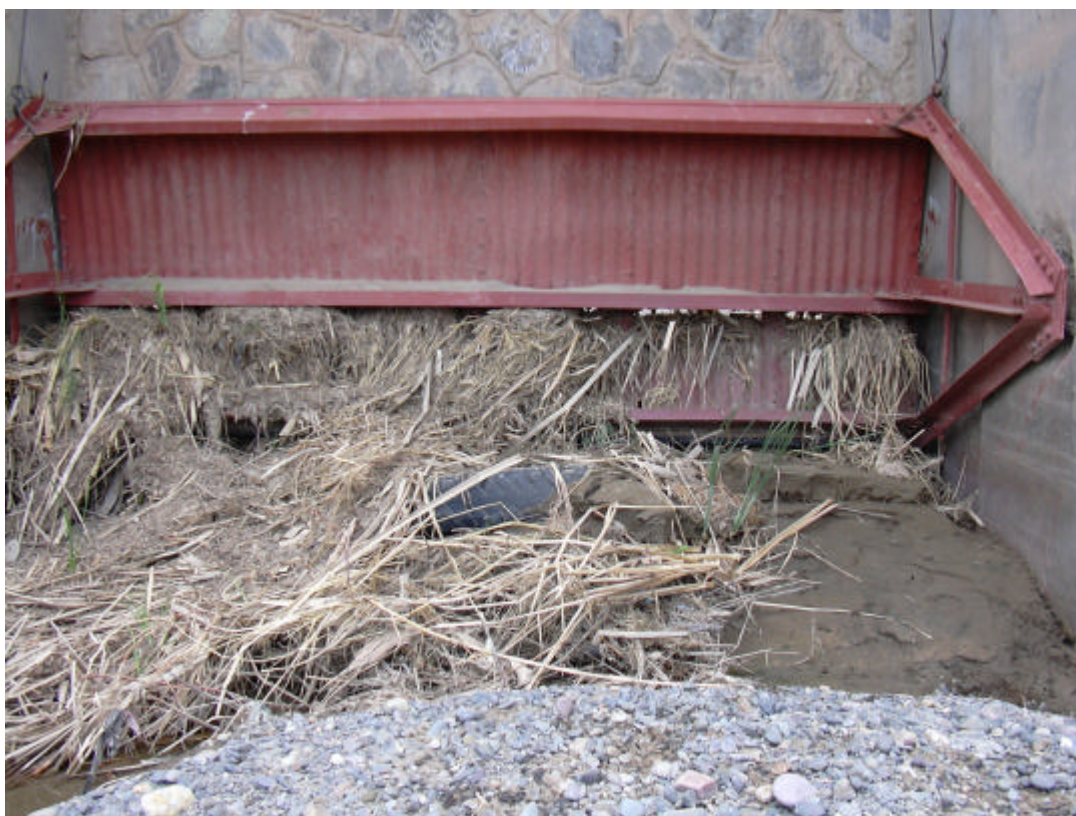
Photographs of Beizag Weir:

WADI TUBAN GATE DETAILS – Location Of Structure: Beizag Weir
Number/Type of gates: 6 no. radial gates
<p>Description of gates:</p> <p>The weir was constructed around 1965. Armco gates with corrugated steel skin plates were installed. Four gates are 12 feet wide (3.6m), the other two gates are 8 feet wide (2.4m). The smaller gates have a single wire rope lifting winch, the larger gates have twin wire ropes. The lifting mechanisms are the original Armco winches.</p>
<p>Condition of Gates and Lifting Machinery:</p> <p>The corrugated skin plates on all six gates have deteriorated due to corrosion. The smaller gates have small holes near the bottom of the gates, the larger gates are in worse condition; they have large holes filled with trapped debris. The gate frames and pivots are in good condition and can be re-used. The side, top and bottom seals need replacement. The wire ropes should be replaced.</p> <p>The lifting machinery is generally in good operational condition on all six gates. The side flange plate on gate 1 (nearest operators building) winch drum is broken but it does not affect the operation of the winch. A sheet steel guard has been fitted over gate no.5 winch, which gives protection to the open gearing. No safety latches are fitted to the gears. To avoid run-back, the operator inserts a piece of cardboard between the worm and pinion and this is effective. An alternative method is to insert a bar through the pinion holes.</p>

<p>Recommended Rehabilitation Works:</p> <p>All gates: Existing corrugated skin plates, side seals, top seals, bottom seals and wire ropes to be replaced.</p> <p>Gates 1,2,3,4 and 6 require sheet steel guard fitted over open gears.</p>
Cost Estimate:

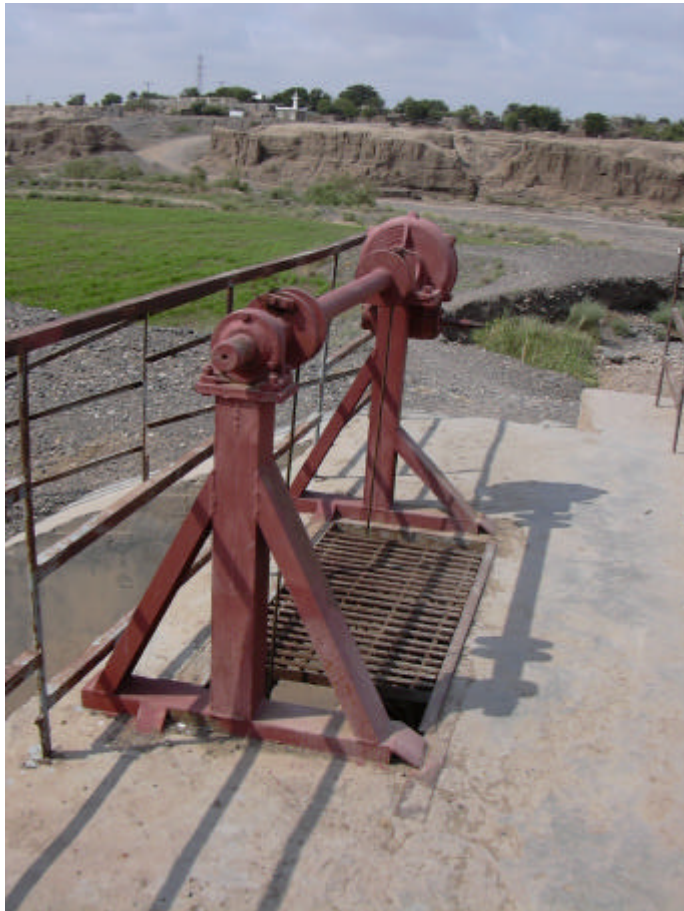
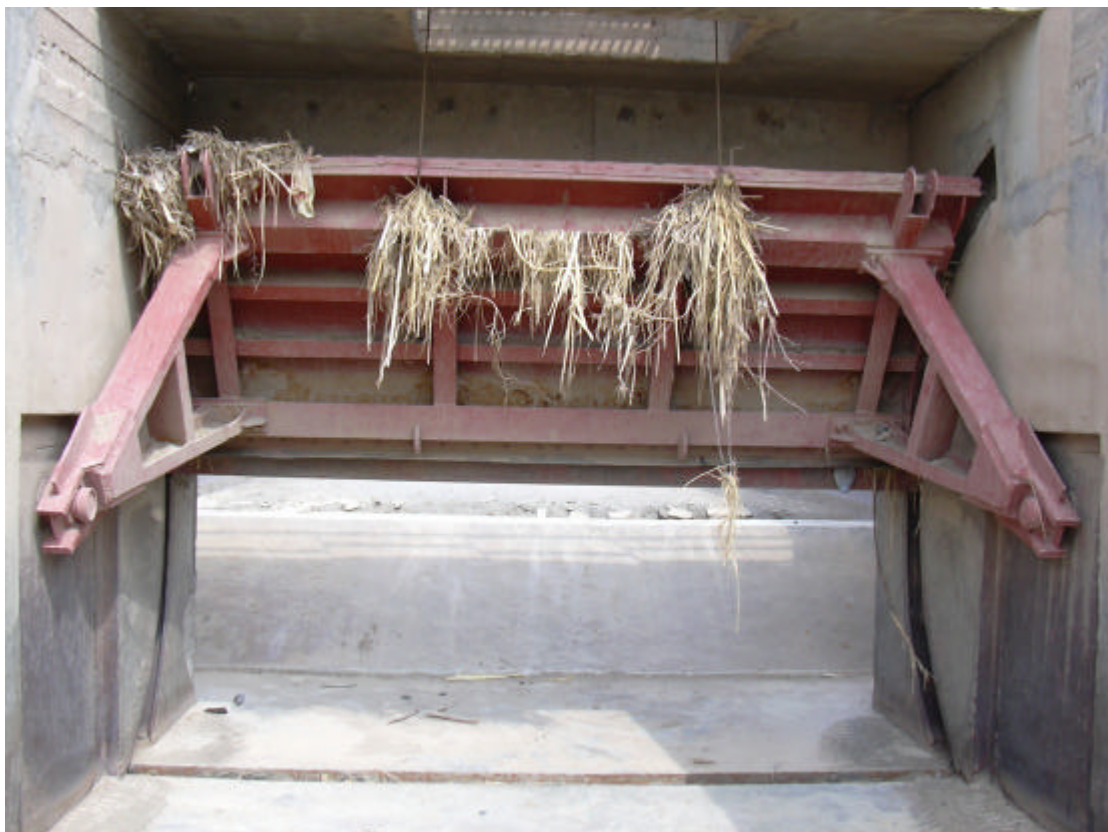
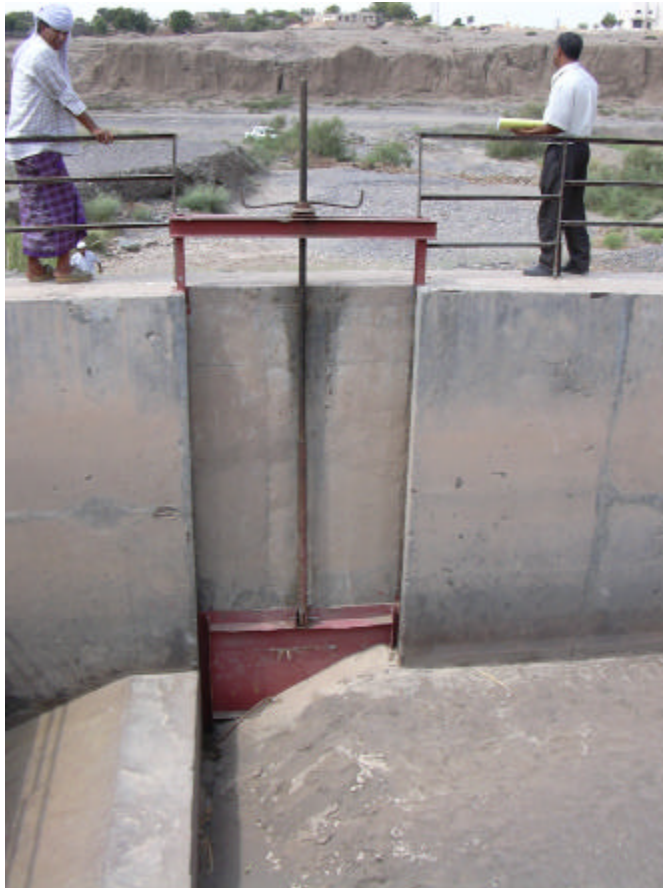
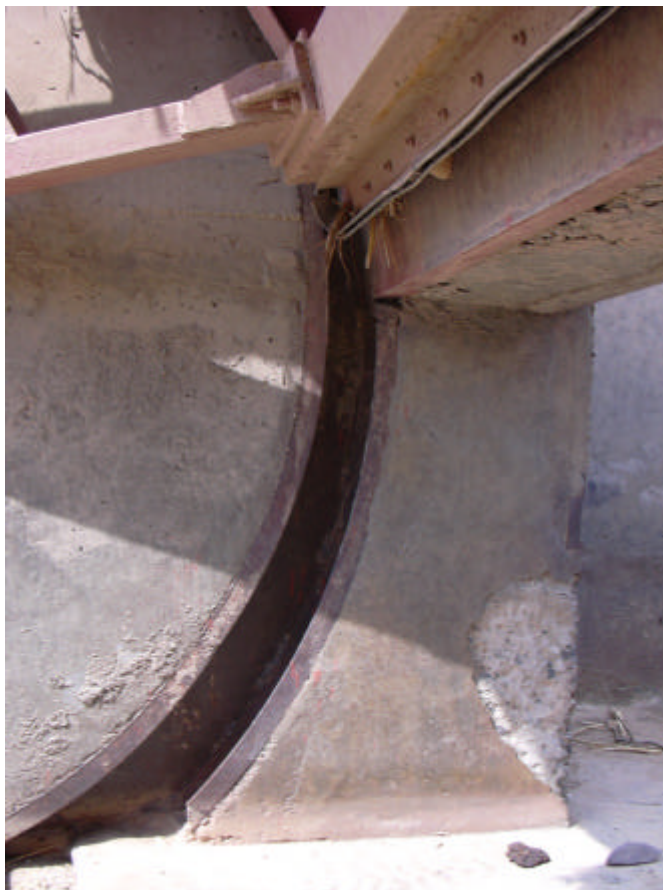
Photographs of Al Taalb:

WADI TUBAN GATE DETAILS – Location Of Structure: Canal Al Taalb
Number/Type of gates: 1 no. radial gate 1 no. vertical sluice gate
<p>Description of gates:</p> <p>Radial Gate: Nominal dimensions are 3.62m wide x 1.45m high x 1.52m radius. The gate is Russian built and was installed in the early seventies. A single winch drives a horizontal shaft with two wire rope drums. The wire rope is a single rope that passes from one drum down to the top of the gate across the gate and up to the other drum. The winch is of Russian origin. The gate is of heavy solid construction.</p> <p>Vertical Sluice Gate: Nominal dimension are 1.52m wide x 1.55m high. 50mm shaft diameter, 3.85m shaft length, height from bottom of gate to top of concrete structure is approx 4m. The gate is installed over a rectangular culvert. Poor quality local manufacture.</p>
<p>Condition of Gates and Lifting Machinery:</p> <p>Radial: The gate was jammed in the raised position due to debris being trapped between the top of the gate and the concrete structure. No maintenance has been carried out for a considerable time. No drain holes in lower horizontal stiffener resulting in trapped sediments and corrosion of the skin plate. The gate is structurally sound and the winch was said to be in operational condition</p> <p>Vertical Sluice: The gate was almost completely buried in sand and could not be moved. The operator reported that when water pressure is applied to the front of the gate the gate distorts and is pushed inside the culvert. The horizontal support at the top of the frame is distorted, so too are the thrust bearing retaining plates.</p>

<p>Recommended Rehabilitation Works:</p> <p>Radial: Overhaul winch gearbox, refill with grease. Provide new wire rope with sufficient length for three spare turns on rope drums when gate is fully lowered. Wire rope to be correctly clamped at rope drums. Replace missing winch fixing bolt. Replace broken grease nipple on one pivot bearing. Provide large diameter drain holes in lower horizontal stiffener. Replace top, bottom and side seals. Mechanically clean corroded paintwork and repaint.</p> <p>Vertical Sluice: Remove existing gate and frame and replace complete assembly.</p>
<p>Cost Estimate:</p> <p>Radial: Vertical Sluice:</p>

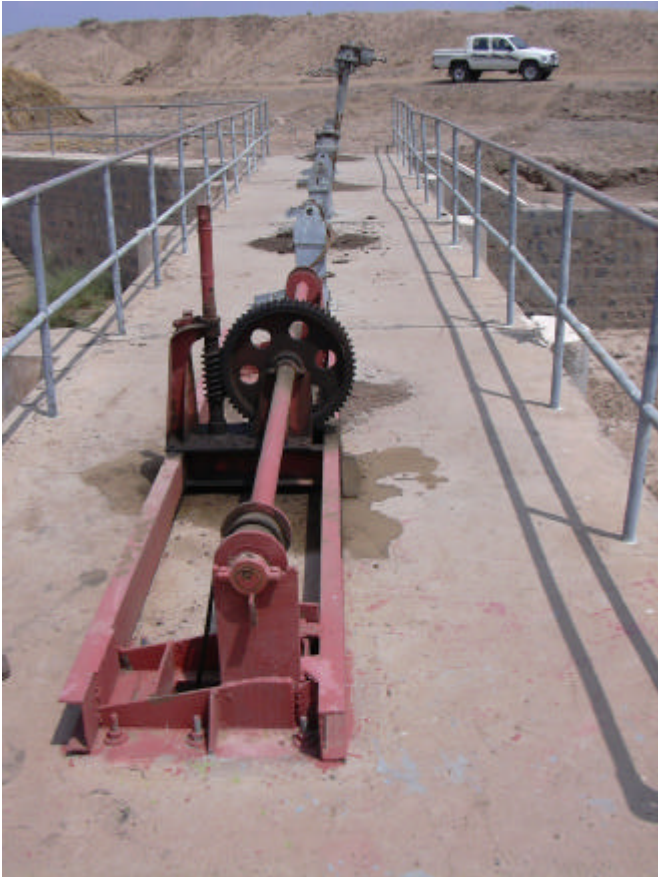
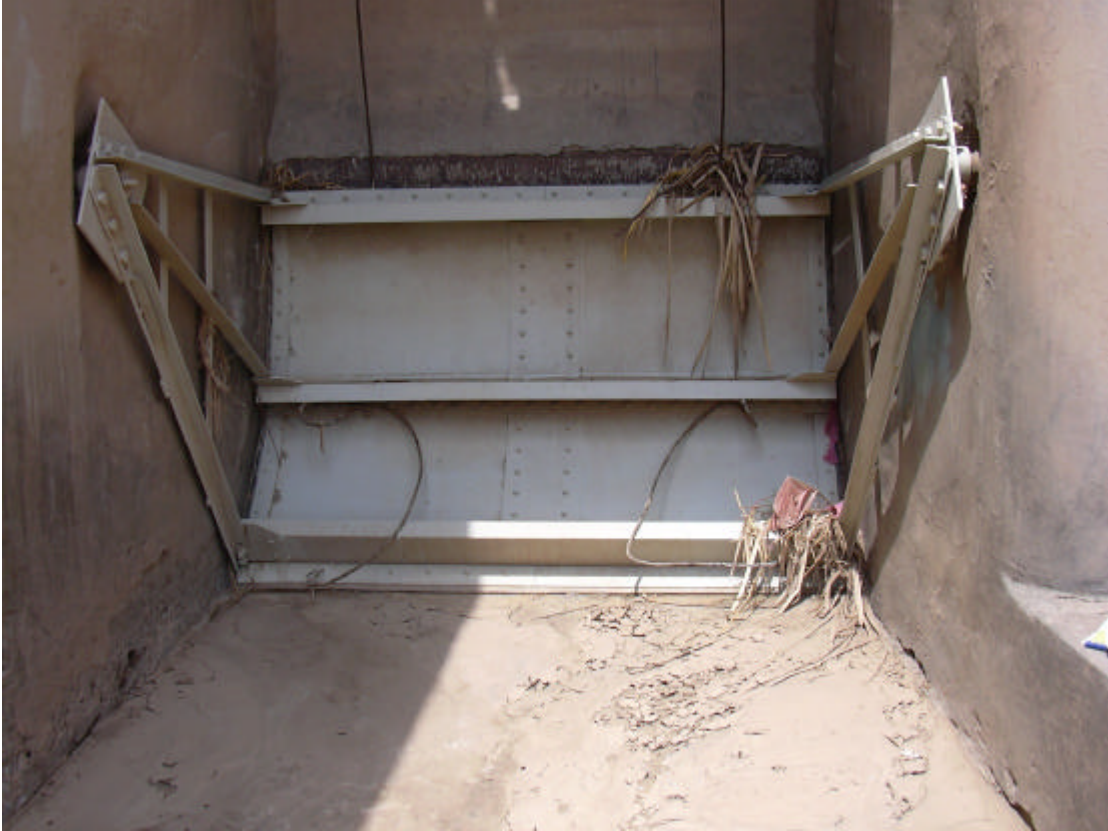
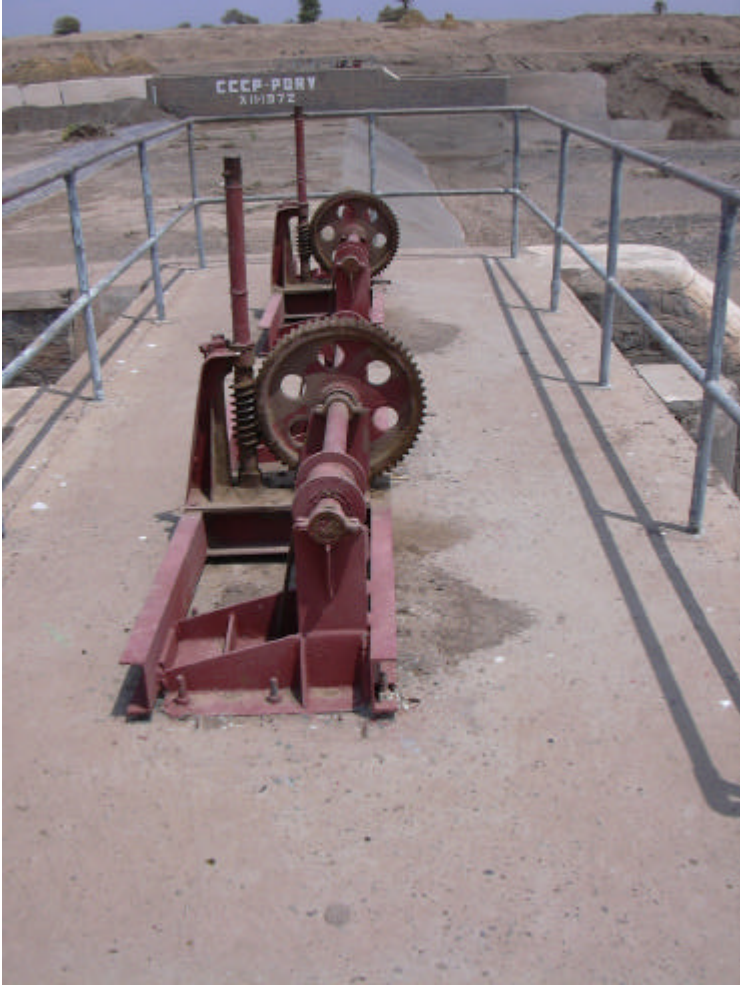
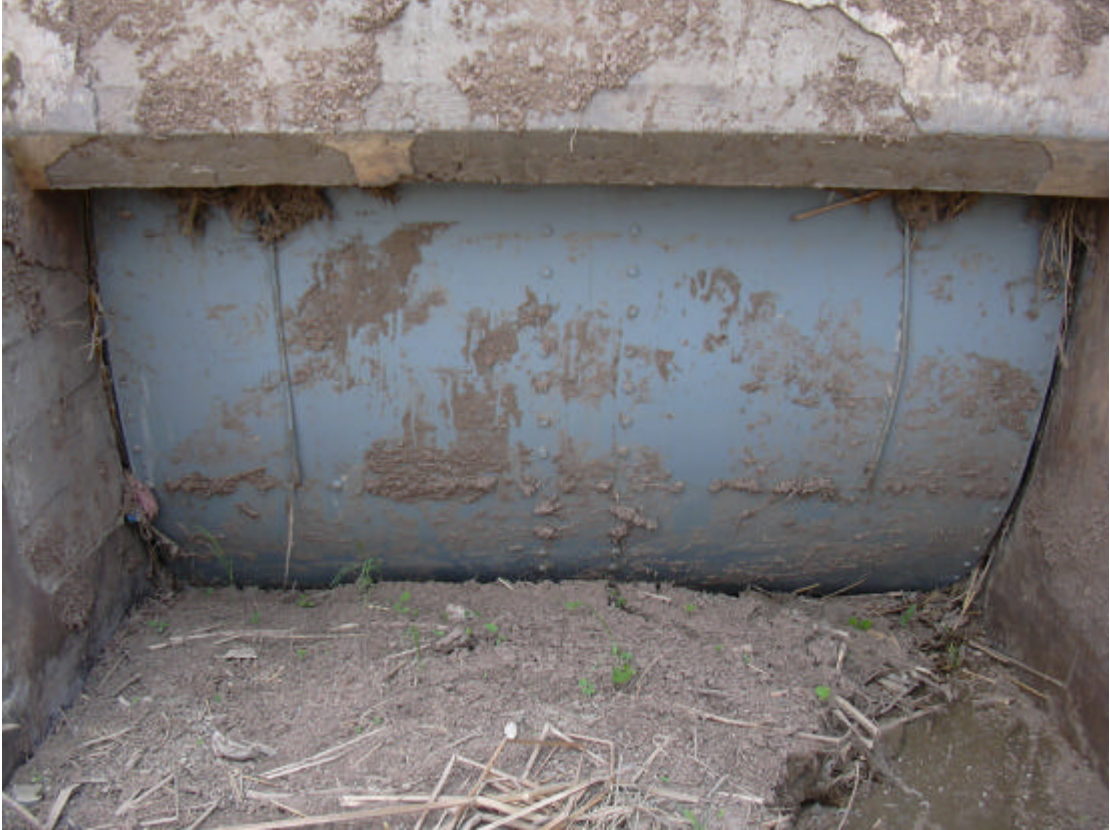
Photos of Al Khadram Weir:

<p>Condition of Gates and Lifting Machinery:</p> <p>The three remaining original gates and machinery at both weirs are not operational the machinery needs to be replaced. The three locally made gates at both weirs are in operational condition but require some modifications to improve their effectiveness</p> <p>The side seals should be renewed. Side rubbing strips are required. There are no top seals.</p>
<p>Recommended Rehabilitation Works:</p> <p>Provide 3 no. new lifting mechanisms at each weir. Provide guards for the 6 no. existing winch gears. Provide side-rubbing strips for 12 no. gates.</p>
Cost Estimate:

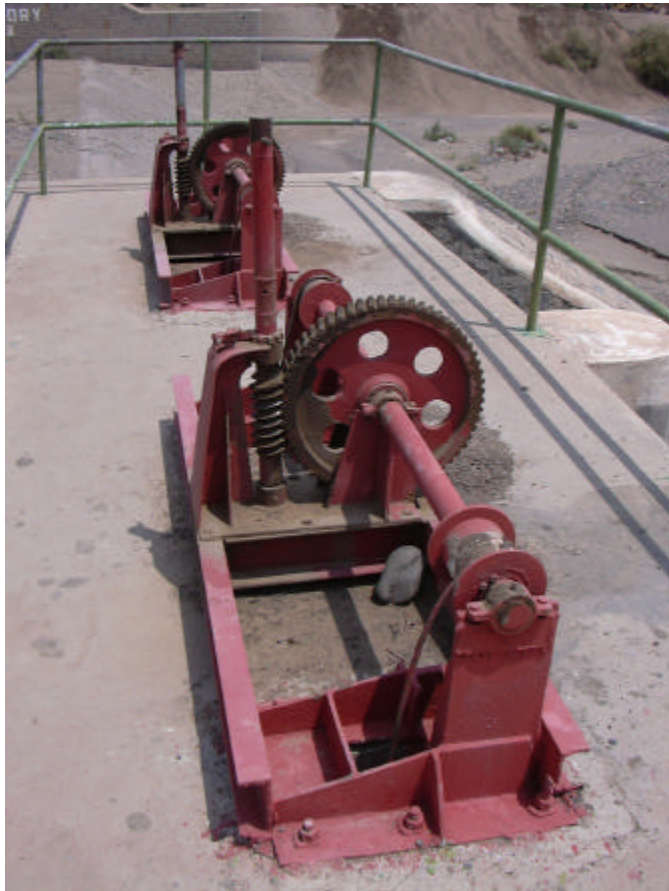
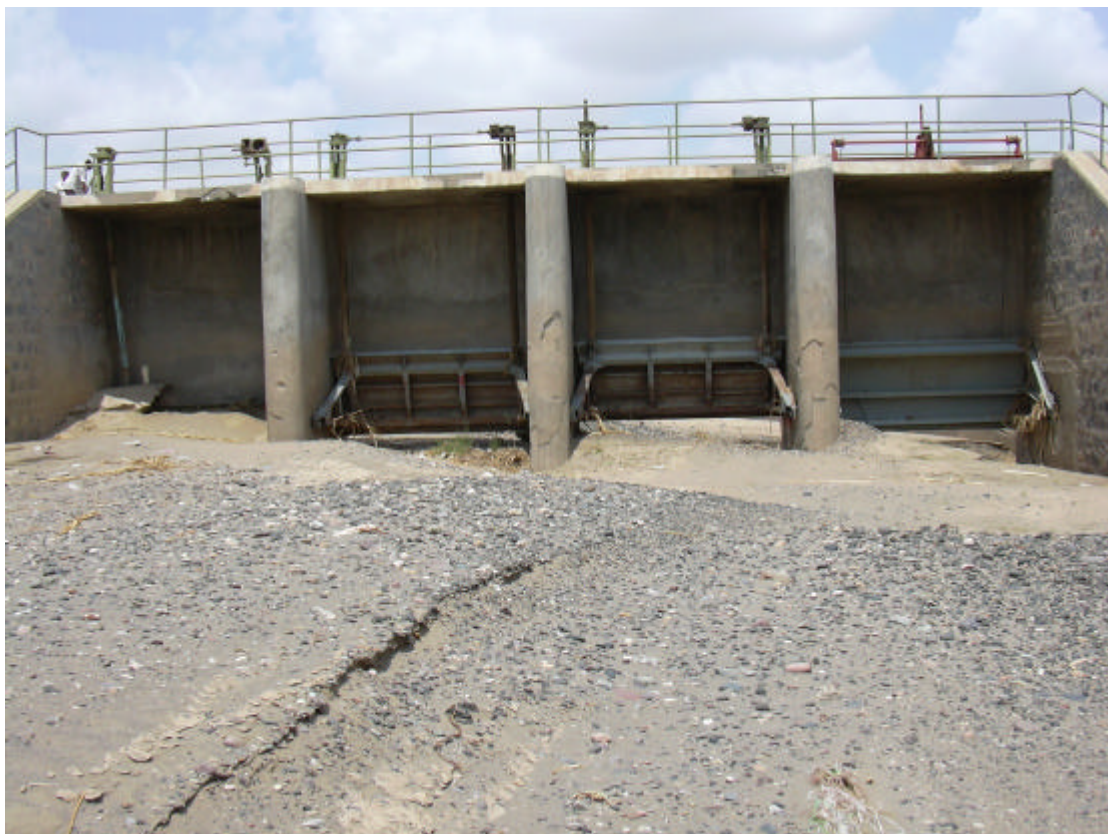
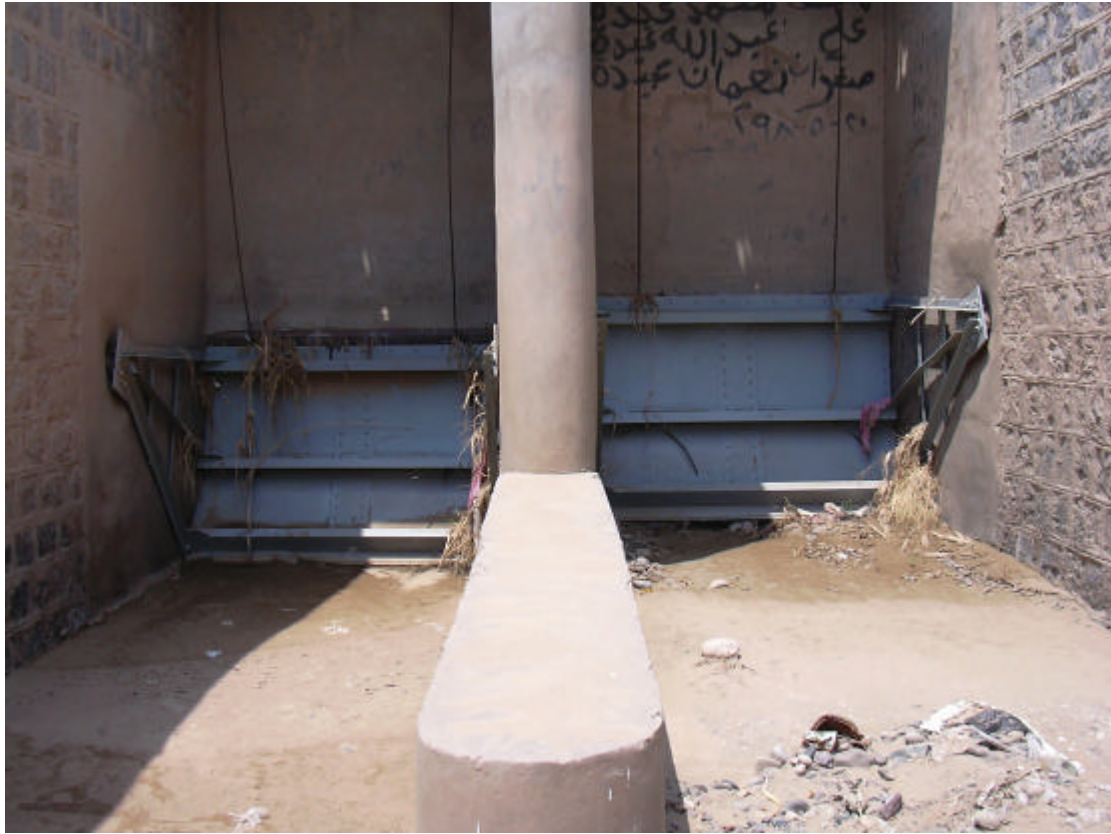
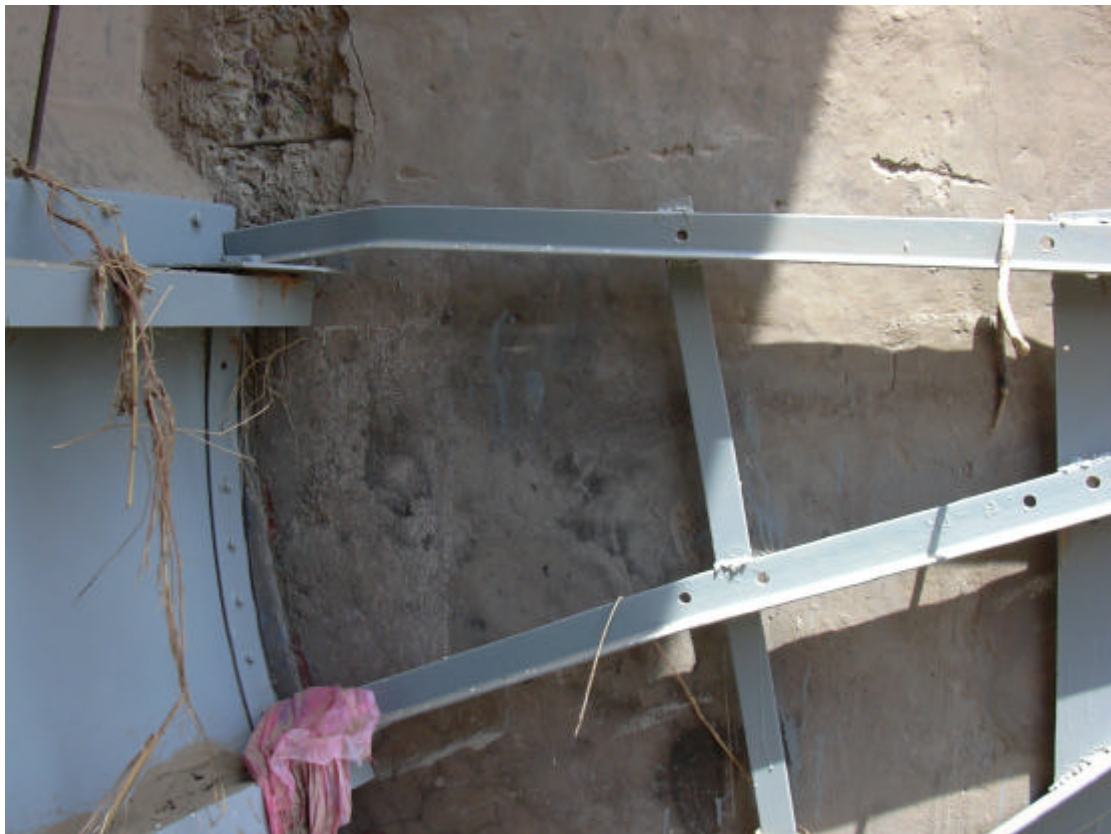
Photographs of Al Bustan Weir:

<p>Condition of Gates and Lifting Machinery:</p> <p>The three remaining original gates and machinery at both weirs are not operational the machinery needs to be replaced. The three locally made gates at both weirs are in operational condition but require some modifications to improve their effectiveness.</p> <p>The backstays are slightly damaged on one of the smaller gates.</p> <p>The side seals should be renewed. Side rubbing strips are required. There are no top seals.</p>
<p>Recommended Rehabilitation Works:</p> <p>Provide 3 no. new lifting mechanisms at each weir. Provide guards for the 6 no. existing winch gears. Provide side-rubbing strips for 12 no. gates.</p>
<p>Cost Estimate:</p>

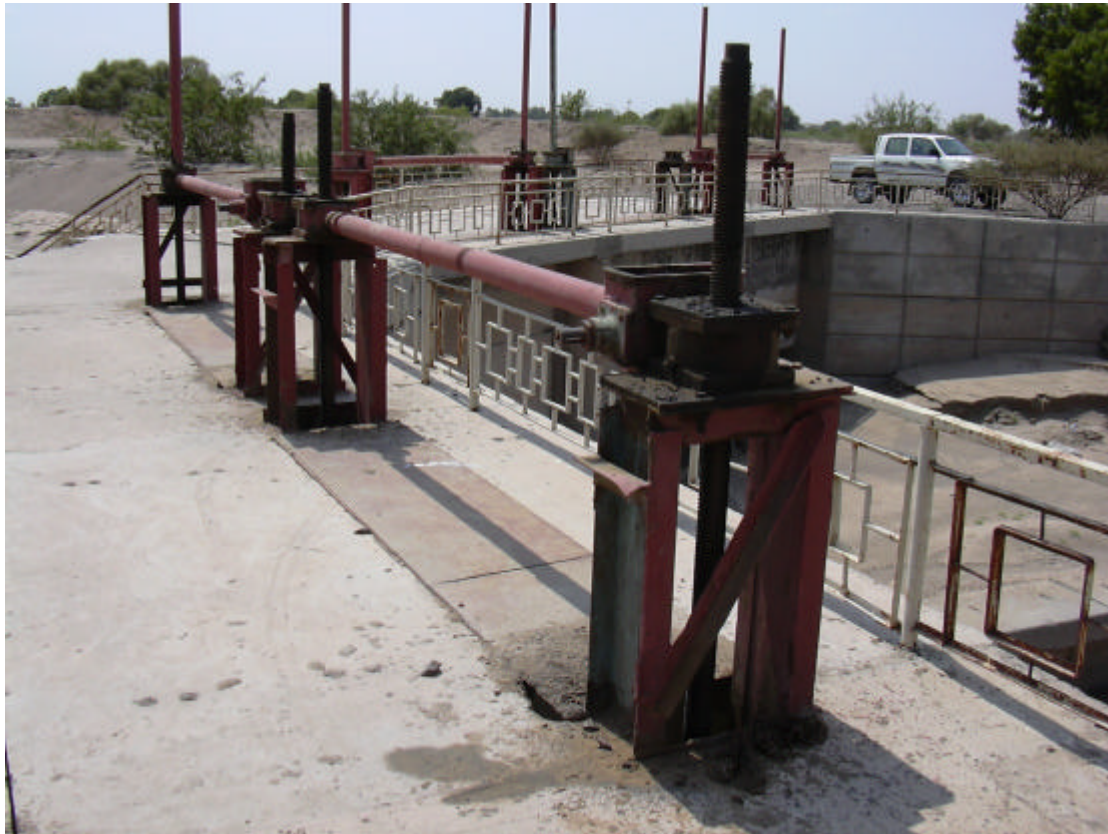
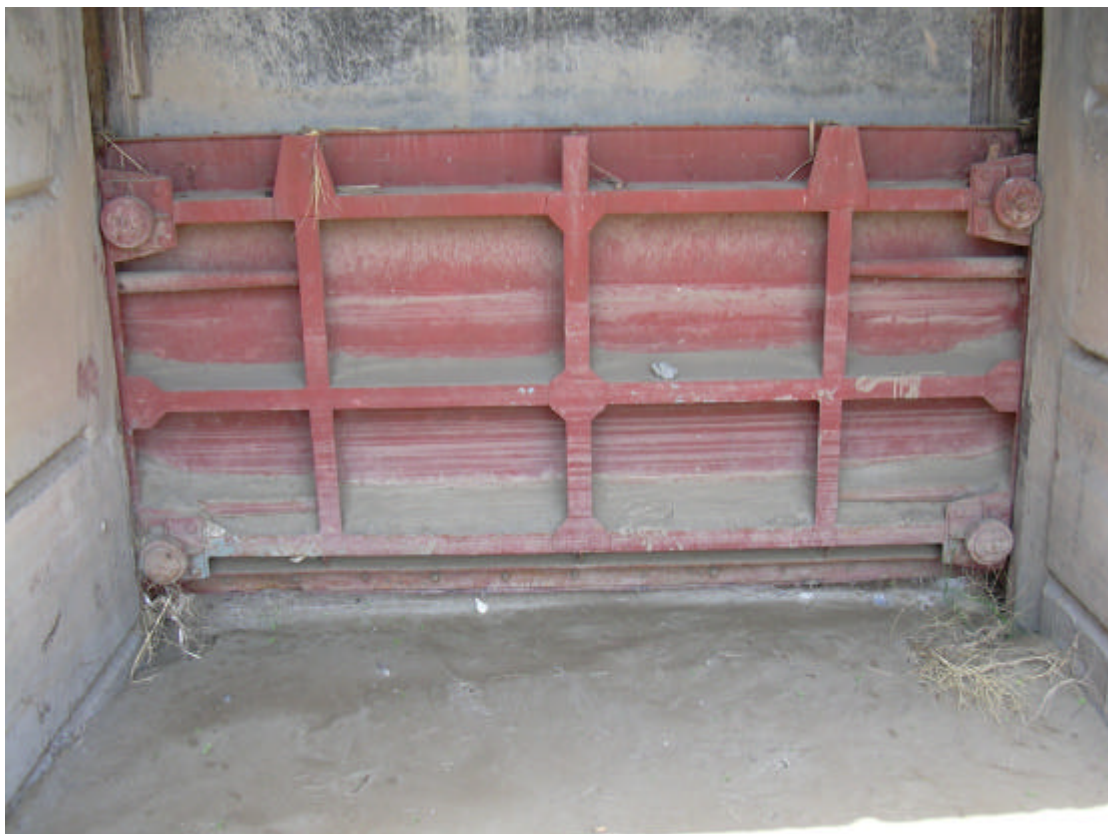
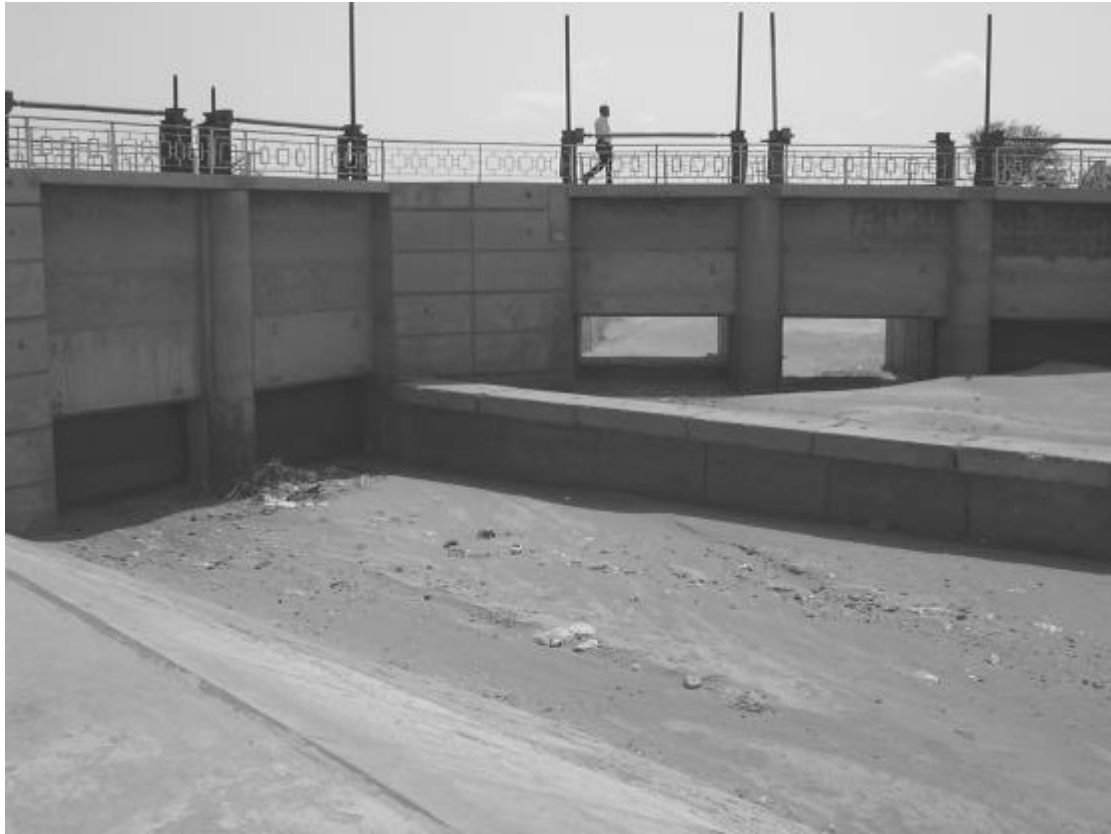
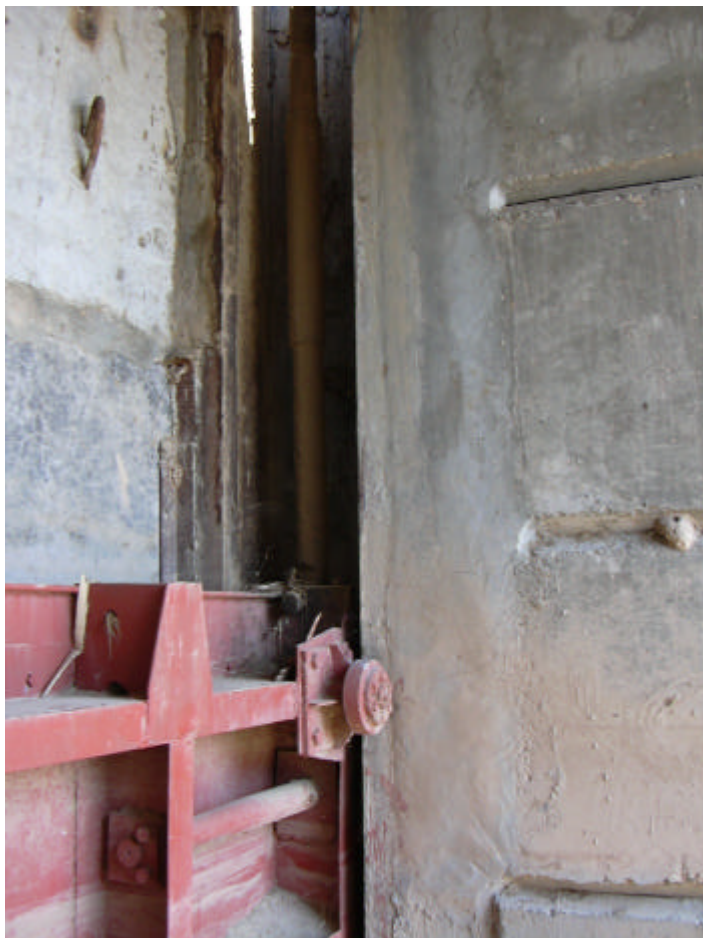
Photographs of Al Manasirah Weir:

WADI TUBAN GATE DETAILS – Location Of Structure: Al Manasirah Weir
Number/Type of gates: 5 no. Vertical sluice gates
<p>Description of gates:</p> <p>The gates are of very heavy construction. Nominal dimensions are 3.5 m wide x 1.67 m high. Deep section horizontal and vertical stiffeners reinforce the front skin plate. Rollers are fitted at the side of the four corners to take the thrust from the water pressure. A further four rollers attached to the back corners of the gate provide lateral constraint. The gates are raised and lowered by a pair of threaded bars fixed at the top corners of the gates. A horizontal shaft through a bevel gear drives the threaded bars. A further bevel gearbox is installed between the hand wind input shaft and the horizontal shaft.</p>
<p>Condition of Gates and Lifting Machinery:</p> <p>The gates are structurally in good condition. Three of the gates are in operational condition but have not been well maintained. The two other gates needs some spare parts for the lifting mechanism.</p>

<p>Recommended Rehabilitation Works:</p> <p>It requires significant effort and time to raise these gates due to their heavy construction. However in view of the infrequent operation and the location (it is the final weir in the wadi and gets the least water) the most cost effective solution may be to overhaul the gates. Each gate requires new side, top and bottom seals, the roller wheels need to be stripped down and lubricated, the bevel gearboxes should be drained, cleaned, refilled with oil and new cover plates fitted, the threaded shafts should be cleaned and re-greased, replacement parts i.e. drive shaft, gears, shaft covers could be salvaged from other installations where possible or manufactured. The gates should be repainted as necessary.</p>
<p>Cost Estimate:</p> <p>It is assumed that some spare parts for the lifting mechanisms will be obtainable from other installations that are being scrapped. Most of the rehabilitation work is manual.</p>
