IRRIGATION IMPROVEMENT PROJECT

WORKING PAPER 8

Gates Assessment

Interim Report

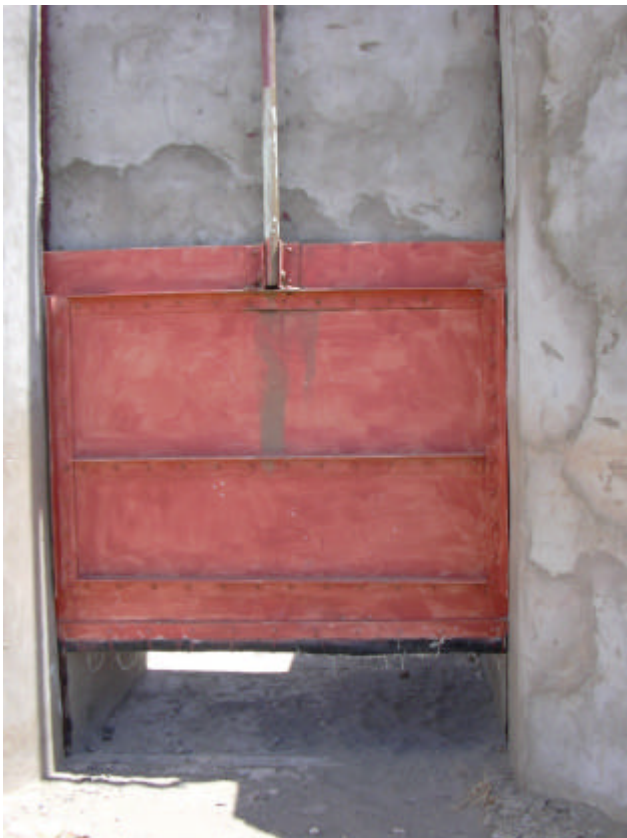
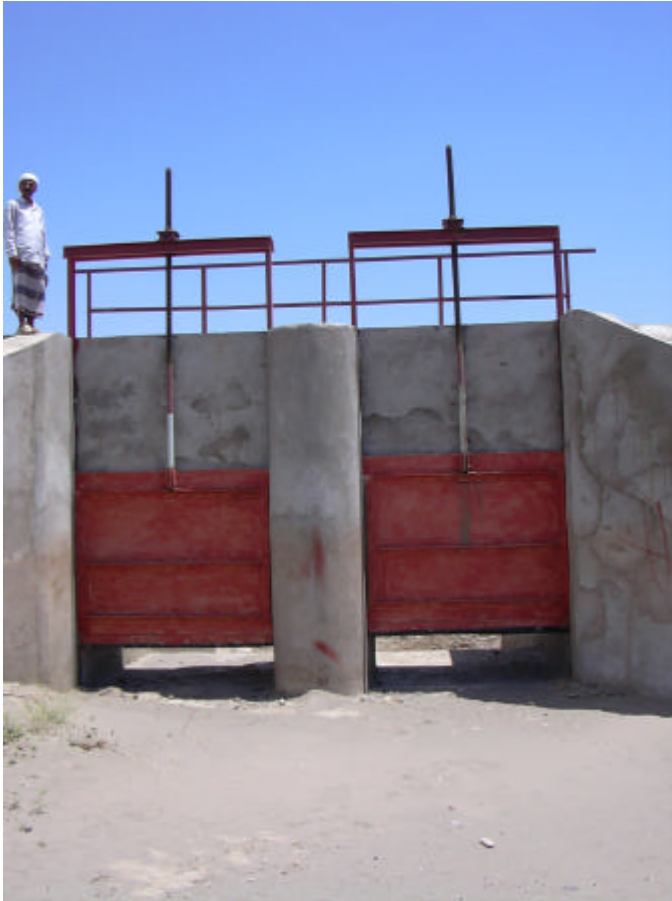
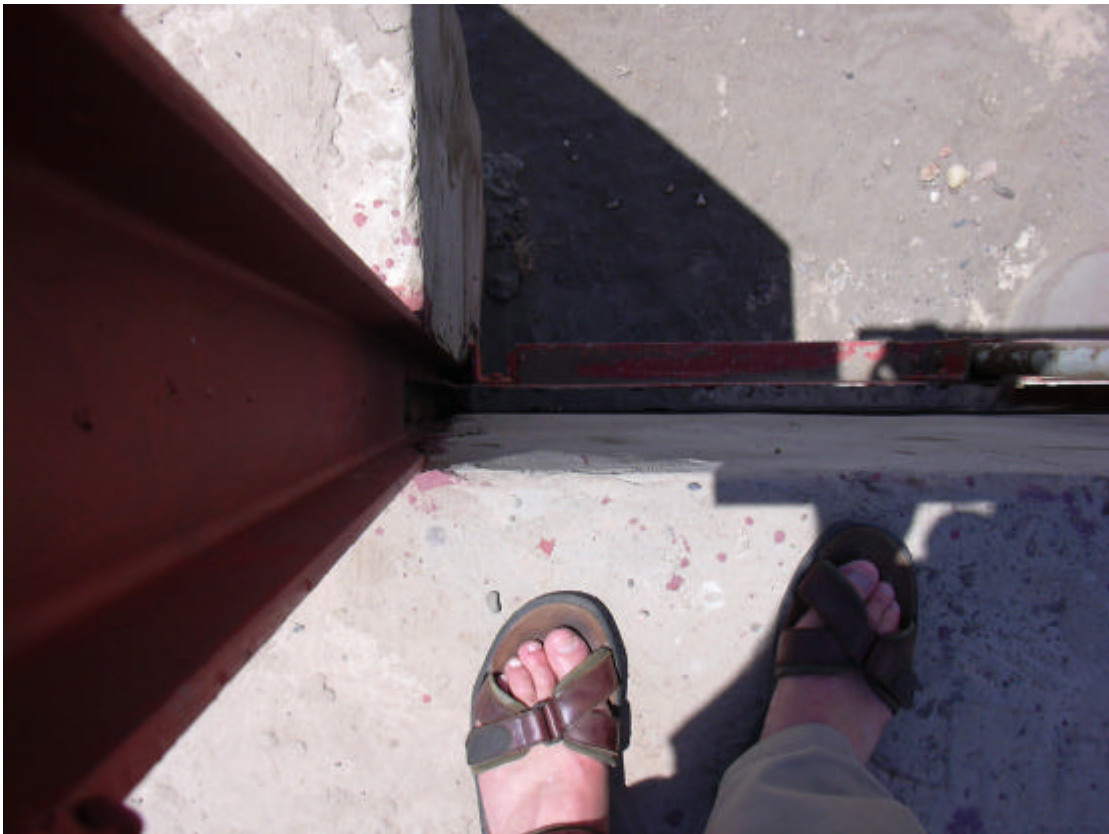
Photos:

WADI TUBAN GATE DETAILS – Location Of Structure: Al Gadid Intake
Number/Type of gates: 2 no. vertical sluice gates
<p>Description of gates:</p> <p>Nominal gate dimensions are 2.1m wide x 1.7m high. The gates are retained within a 100 x 50 channel section frame and have a 4mm skin plate reinforced by bolted angle sections.</p>
<p>Condition of Gates and Lifting Machinery:</p> <p>The gates are relatively new. The design is acceptable. The quality of fabrication is satisfactory. The thrust bearing assembly is more compact than those previously seen. Spacer tubes have been fitted over the bolts between the retaining plates to avoid over compression and bending of the plates. The bottom seal is too long and unnecessary as the other sides do not have seals.</p>
<p>Recommended Rehabilitation Works:</p> <p>The gates do not require any rehabilitation work.</p>
<p>Cost Estimate:</p> <p>Nil</p>
