1st Annual Leadership Course in FBFS and WHR

Report of Group 3:

Review adequacy of technical means of the spate irrigation . . .

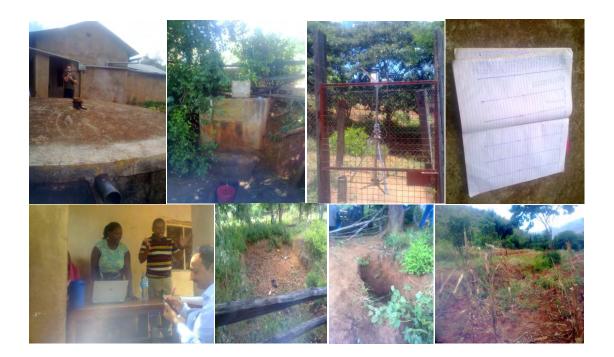
Part I. Visiting Bangalala Village

- Significant water loss in unlined canals
- In division boxes the slot gates are not used
- They use stones, mud, grass, etc..
- Canal bed scour on the drops
- Improper location of the de-silting basin

- Line the canal
- Use proper slot gates
- Construct new de-silting basin as a escape canal location
- Frequently clean the de-silting basin
- Maintain the canal scour or place flat stones at the canal drops
- Having road crossing structure
- Collect some money from the farmers for the water they use
- Install a micro hydropower and use it for watermill which can generate substantial money for the canal maintenance
- introduce high value crops

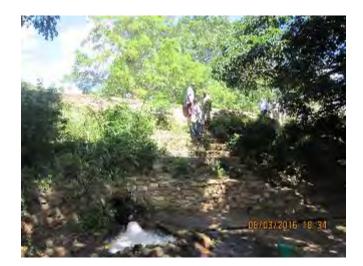
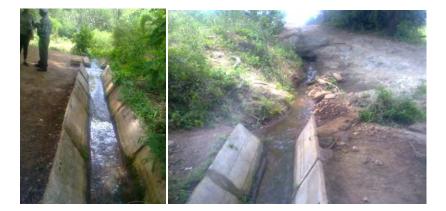
Part II. Visiting Microdam Site

- Ndiva (6 acr)
- Maintenance (seasonal; volunteer- every Tuesday; and no maintenance for canals from the source to the dam due to the geological formation of the canal 'naturally flowing': only 20% reaches the dam)
- Intake structure for diverting water to the Ndiva from the spring (weir upstream before Ndiva)
- Unlined 4 KM canal from the intake to the Ndiva
- Lined canal around 20M near the canal
- De-silting basin
- Spillway always open in case of emergency
- Division box outside the Ndiva to divide water into two canals

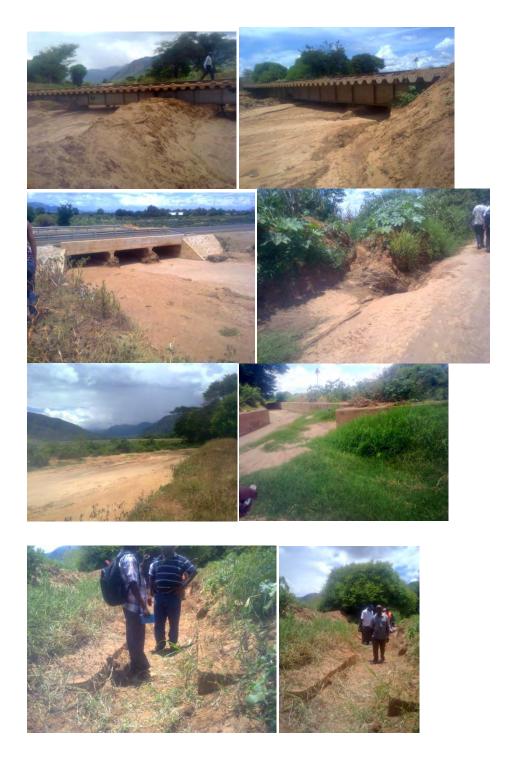
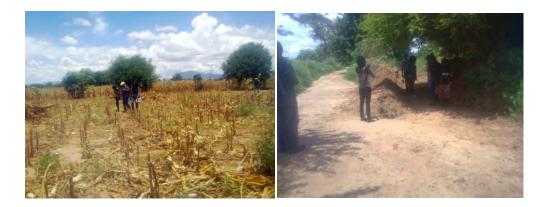
Part III. Visiting Makanya Village; Lowland

- Canal sedimentation
- Due to the railway bridge, the water directs to the left canal; it is difficult to divert the water to the right command area
- The existing diversion structure aggravates the sedimentation effect

- Try to minimize the coming sediment by doing soil and water conservation activities in the uplands
- Try to make the railway bridge (floor) elevation equal. This may be done by laying riprap stones or boulder; open the bridge spans equally to get uniformly distributed water
- Modify the existing U diversion structure to a triangular structure by using 10M upstream space
- Although the advantages of the sedimentation: increasing the command area and bringing fertile soil; sandy soil will be collected in the area after a while
- Conservation of upper catchment as a strategy to reduce siltation menace
- Get regular meteorological information from nearby station specifically for Makanya sub- catchment- this will help farmers plan better for floods
