IRRIGATION IMPROVEMENT PROJECT

WORKING PAPER 8

Gates Assessment

Interim Report

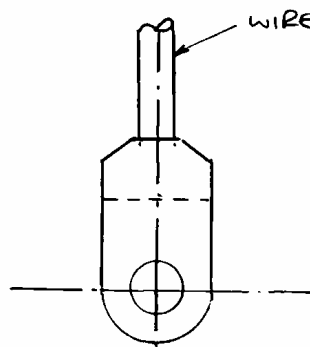
SKETCH 1

CLEVIS FOR FIXING WIRE ROPE TO GATE.
(INDICATIVE ONLY - NOT TO SCALE)

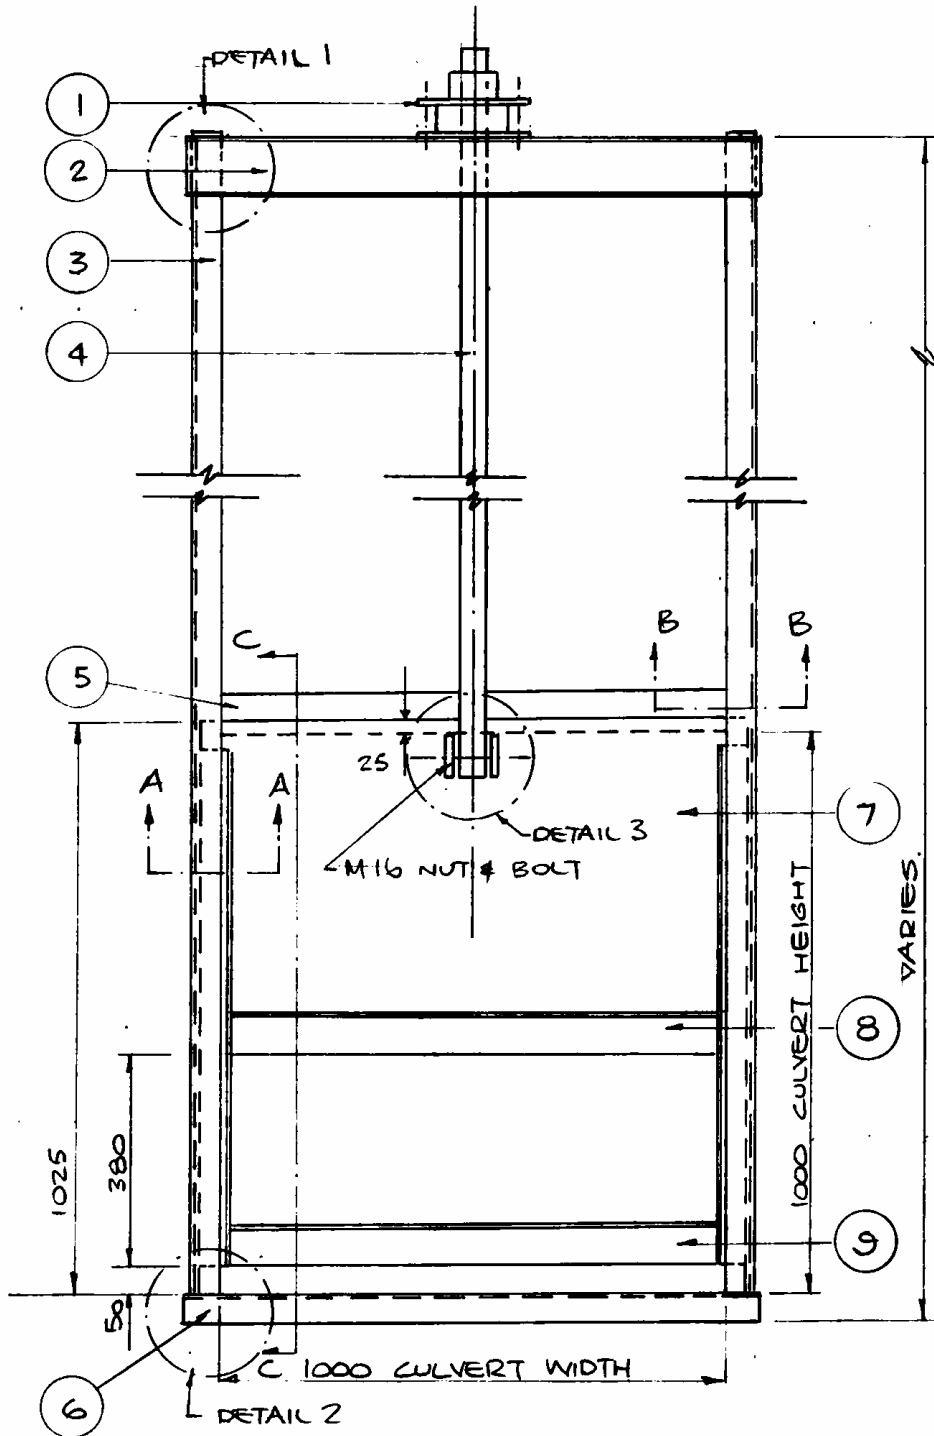
Figure 2a Replacement 1000 x 1000 Vertical Sluice Gate for Wadi Tuban, sheet 1 of 4

VERTICAL SLUICE GATE FOR 1000 x 1000 CULVERT
